Aviation Investigation Final Report

Location:	Oshkosh, Wisconsin	Accident Number:	CEN23FA333
Date & Time:	July 29, 2023, 12:27 Local	Registration:	N193AZ (A1); N221EL (A2)
Aircraft:	Rotorway 162F (A1); ELA ECLIPSE 10 (A2)	Aircraft Damage:	Destroyed (A1); Destroyed (A2)
Defining Event:	Midair collision	Injuries:	2 Fatal (A1); 2 Serious (A2)
Flight Conducted Under:	Part 91: General aviation - Personal (A1); Part 91: General aviation - Personal (A2)

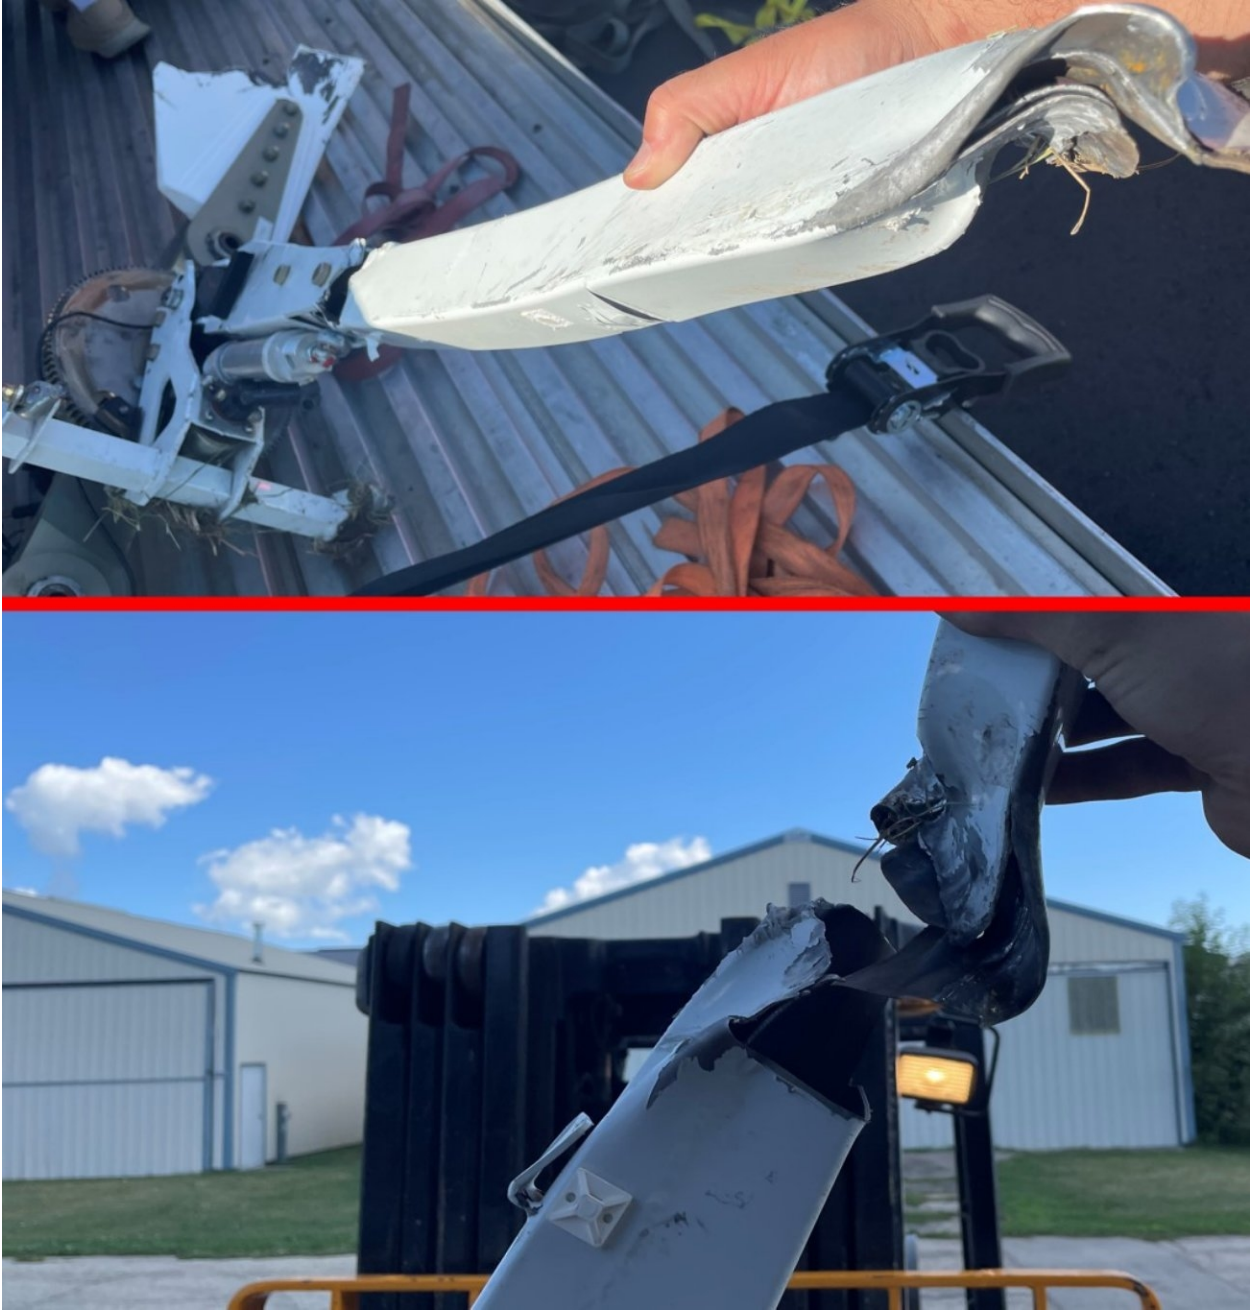
The gyroplane's right horizontal and vertical stabilizers displayed shear cuts and separated structure consistent with helicopter main rotor blade contact (see figure 5). The gyroplane's main rotor mast was separated about mid-length with an impact signature consistent with the helicopter's main rotor blade (see figure 6).

Figure 6. Gyroplane's separated rotor mast section and the helicopter's main rotor blade contact witness mark.
