# Aviation Investigation Preliminary Report

<b>Location:</b>	Whitesville, KY	<b>Accident Number:</b>	ERA23FA380
<b>Date &amp; Time:</b>	September 27, 2023, 22:49 Local	<b>Registration:</b>	N3079M
<b>Aircraft:</b>	Piper PA28	<b>Injuries:</b>	2 Fatal
<b>Flight Conducted Under:</b>	Part 91: General aviation - Instructional

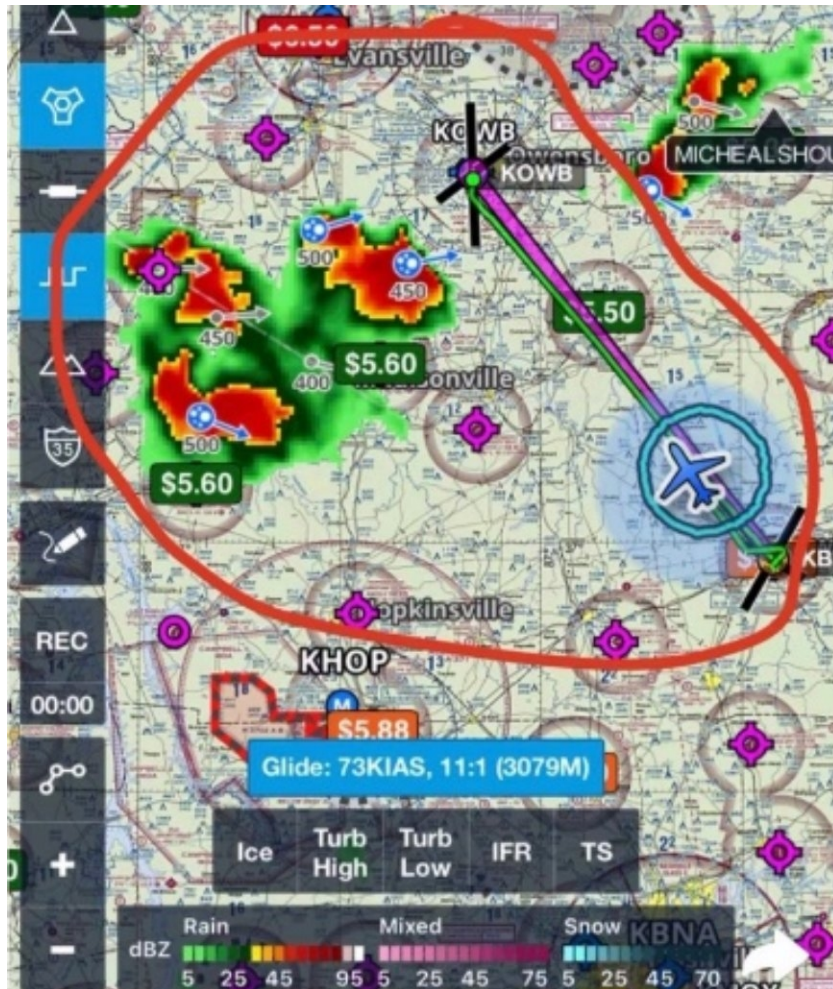
A post to the flight instructor’s social media account at 2215 (about 34 minutes before the accident) depicted an annotated image from a mobile-device-based aviation navigation tool. The image depicted the airplane’s current position northwest of Bowling Green, Kentucky, along with the planned route of flight to OWB. Weather radar imagery was also displayed in the image, which had been annotated with a circle around the flight track and nearby weather radar returns. Figure 1 shows an excerpted screen capture from the flight instructor’s social media post.

Figure 1 - Screen capture of a post to the flight instructor's social media account. Note the airplane's current position (blue airplane icon), the planned route of flight (magenta line), the depicted weather radar imagery, and entire area circled in red.
