Aviation Investigation Preliminary Report

Location:	Portland, OR	Accident Number:	DCA24MA063
Date & Time:	January 5, 2024, 17:14 Local	Registration:	N704AL
Aircraft:	Boeing 737-9	Injuries:	177 None
Flight Conducted Under:	Part 121: Air carrier - Scheduled

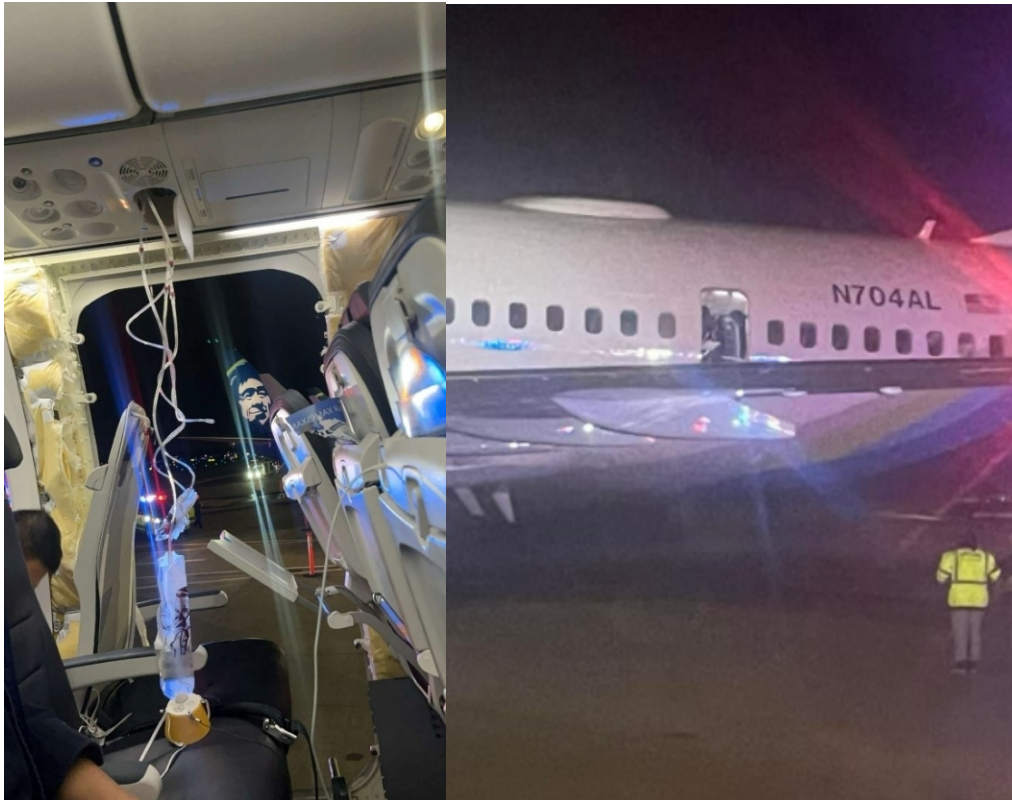
Figure 1 below shows the location of the missing MED plug from inside and outside the airplane. The separation of the MED plug from the airplane adversely affected the pressurization performance of the airplane and the damage to the MED plug adversely affected its structural strength, requiring replacement of the MED plug, resulting in a classification of substantial damage in accordance with Title 49 *CFR* Part 830.

Figure 1. Photos of the location of the missing MED plug. (Source: left photo provided by a passenger. Right photo provided by media.)

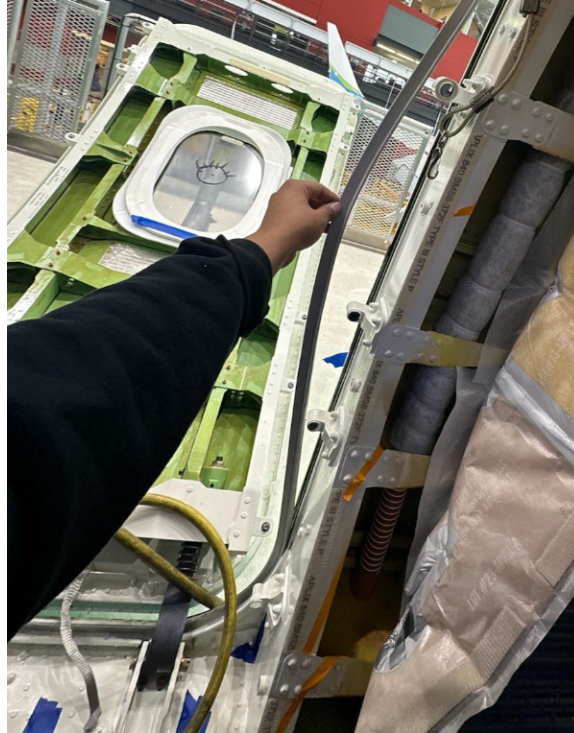
Documents and photos show that to perform the replacement of the damaged rivets, access to the rivets required opening the left MED plug (see figure 15). To open the MED plug, the two vertical movement arrestor bolts and two upper guide track bolts had to be removed.

Figure 15. Photo showing the MED plug opened to work on damaged rivets. (Source: Spirit AeroSystems.)
