Aviation Investigation Final Report

Location:	Lake Placid, New York	Accident Number:	ERA24FA001
Date & Time:	October 1, 2023, 16:08 Local	Registration:	N545PZ
Aircraft:	Cessna 177RG	Aircraft Damage:	Substantial
Defining Event:	Loss of engine power (partial)	Injuries:	2 Fatal
Flight Conducted Under:	Part 91: General aviation - Other work use

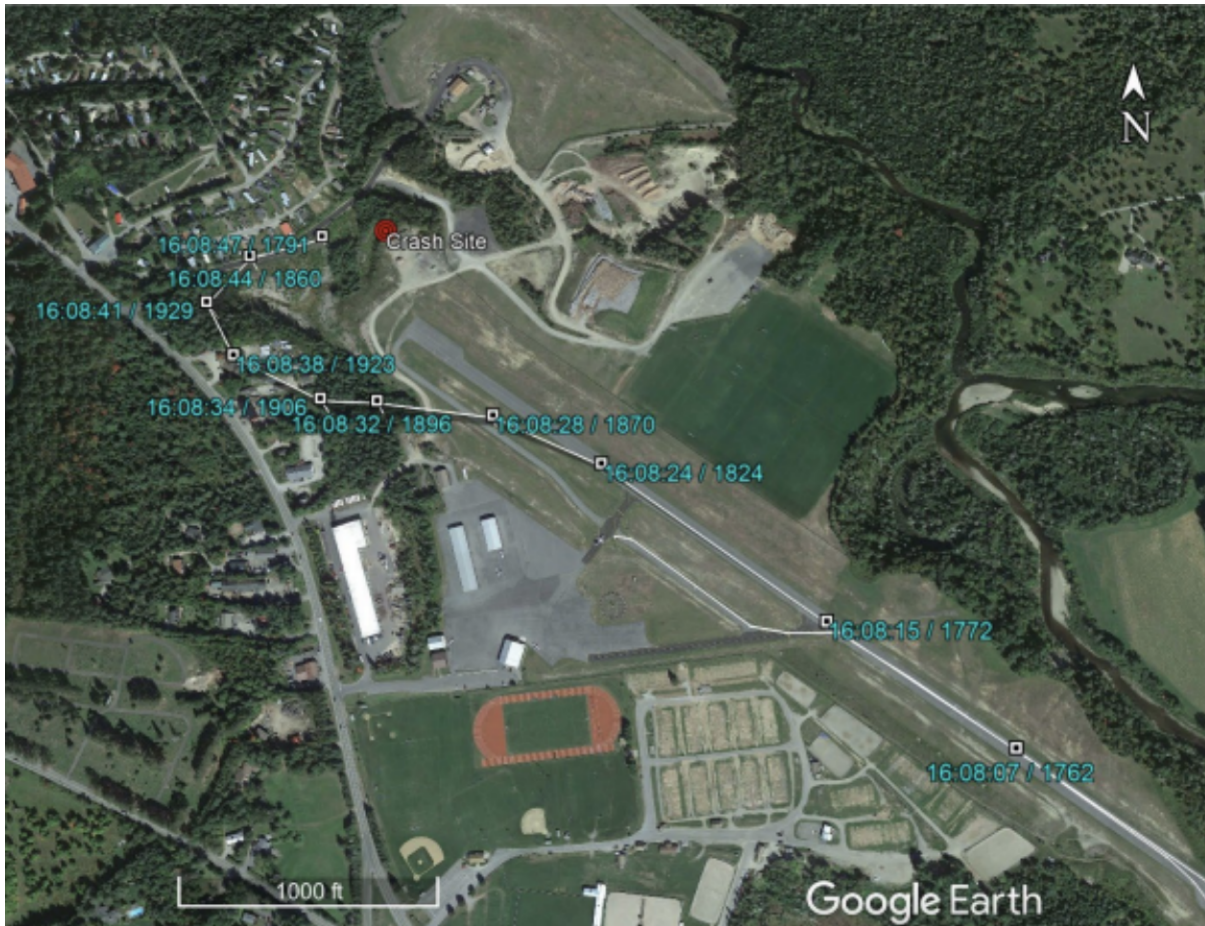
At 1608:41, the lift coefficient exceeded the airplane's expected value of CLmax calculated from the POH, which was indicative of an aerodynamic stall. Also at 1608:41, the roll angle reached a maximum of 39°, the airspeed reached a minimum of 52 KCAS, and the altitude reached a maximum of 1,929 ft msl, followed by a sharp drop at -1,300 ft/min; all of these parameters showed behavior consistent with an aerodynamic stall. At 1608:41, the airplane was turning right, but the recorded ground track angle at that time was 330.8°, an angle of about 25° relative to the true alignment of runway 32 at 306°, which indicated that the airplane

was still traveling away from the airport at that time. Figure 1 shows the airplane's position and altitude during the accident flight with respect to the takeoff runway and the crash site.

Figure 1 - Overhead view of the accident flight path overlaid on top of an aerial image of the airport. Annotations indicate the time (hh:mm:ss) and recorded altitude (ft msl). The crash site is indicated by a red circle.

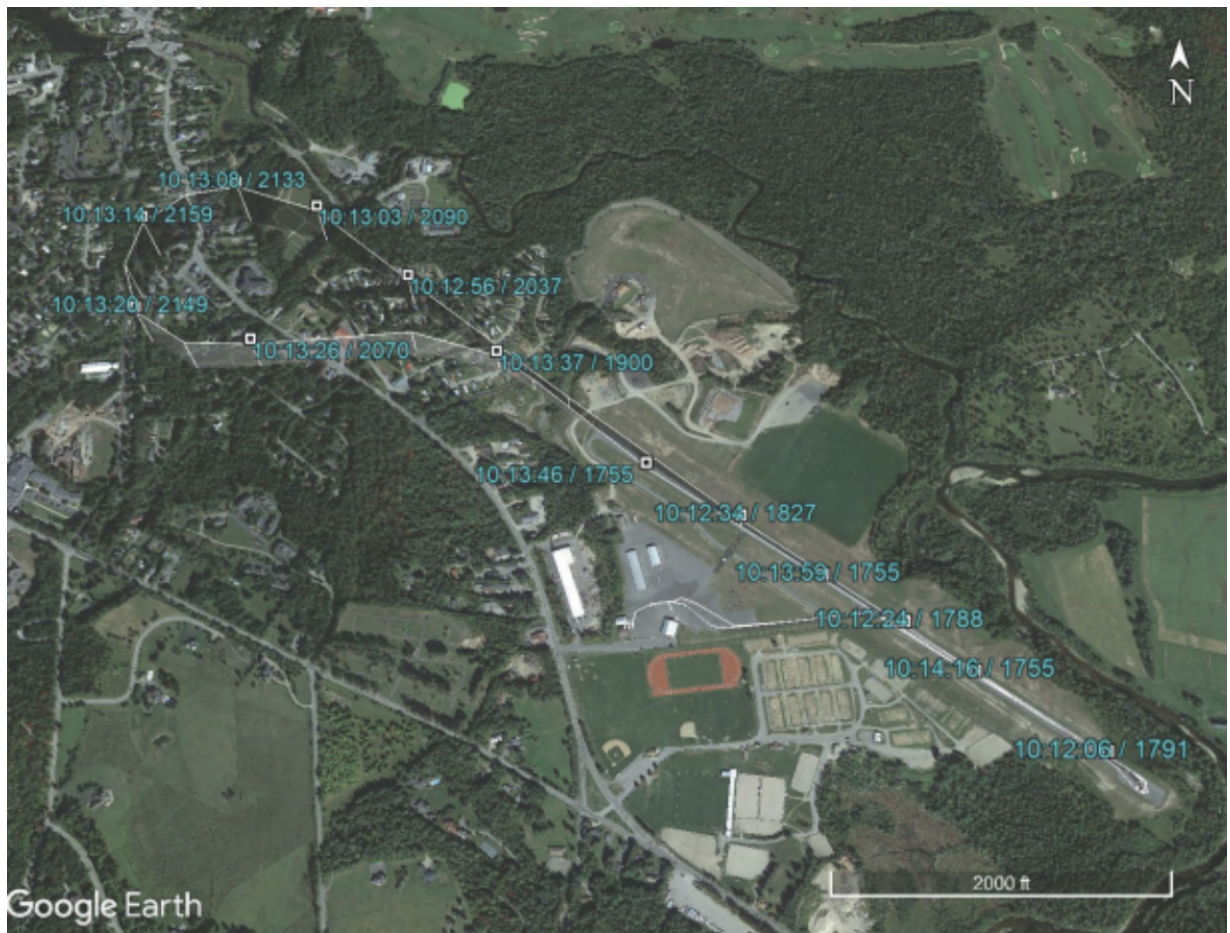
Review of the GPS data revealed that the practice flight occurred on September 17, 2023, and that the airplane departed LKP and immediately returned to the airport. The airplane lifted off from runway 32 shortly after 1012:20, but it began a sharp roll to the left at 1012:56, reaching a roll angle of -40° at 1013:20 before rolling back to the right. The airplane then reached a roll angle of 27° at 1013:37 as it aligned with runway 14. During the left turn, the track angle changed by about 9.6° per second, as compared with a standard rate turn of 3° per second. The airplane reached an altitude of about 400 ft agl during the left turn and subsequently descended and landed on runway 14 about 1013:46. Figure 2 shows the airplane’s position and altitude during the September 17 flight with respect to the takeoff runway.

Figure 2 - Flight track for the practice flight 2 weeks before the accident flight overlaid on top of an aerial image of the airport. Annotations indicate the time (hh:mm:ss) and recorded altitude (ft msl).
