# Aviation Investigation Final Report

<b>Location:</b>	Allentown, Pennsylvania	<b>Accident Number:</b>	CEN22FA436
<b>Date &amp; Time:</b>	September 28, 2022, 13:40 Local	<b>Registration:</b>	N7329F
<b>Aircraft:</b>	Piper PA-28-140	<b>Aircraft Damage:</b>	Destroyed
<b>Defining Event:</b>	Loss of engine power (partial)	<b>Injuries:</b>	1 Fatal, 1 Serious
<b>Flight Conducted Under:</b>	Part 91: General aviation - Instructional

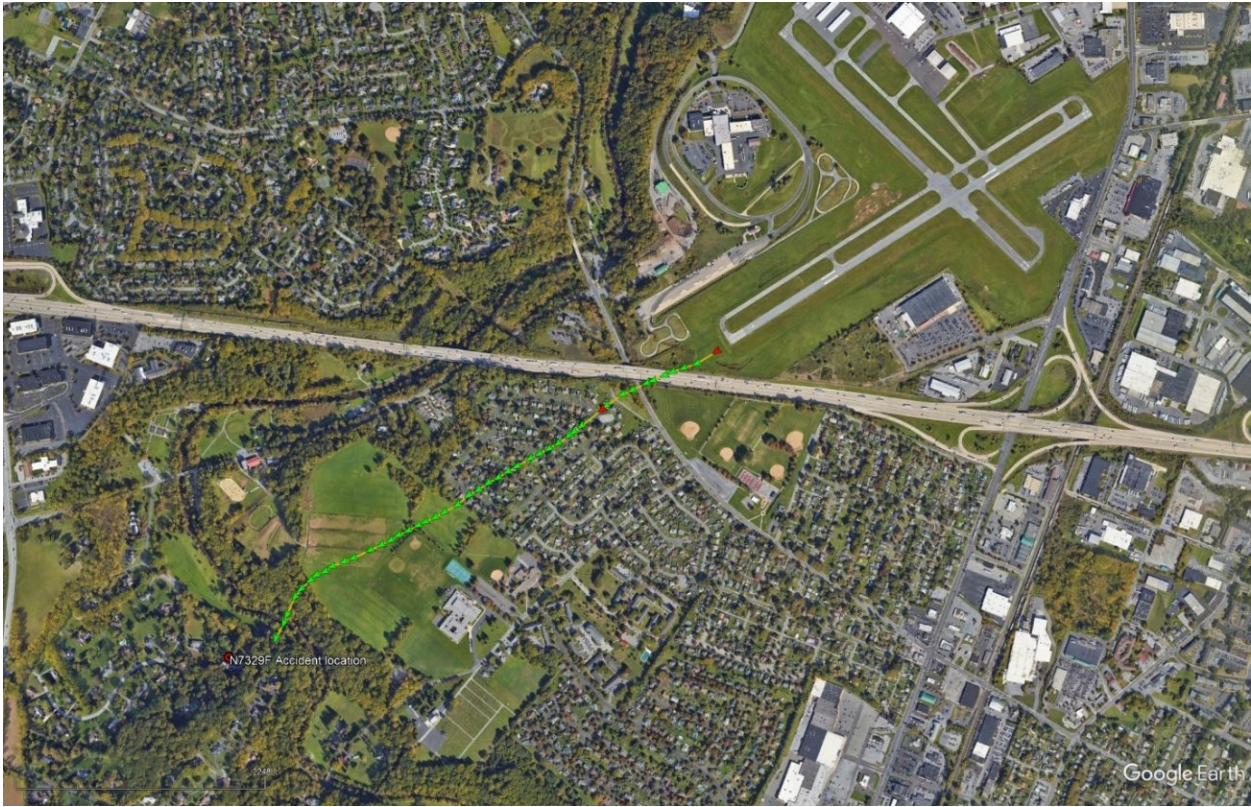
Figure 1. Overhead view of the accident flight path.

Recorded Automatic Dependent Surveillance-Broadcast (ADS-B) data showed that the airplane departed and continued for about 0.8 miles on runway heading, then made a slight left turn before the end of the data. The accident site was about 450 ft and 250° from the final recorded location. The reported wind at the departure airport was from 310° at 8 kts.

Examination of the data, taking into account the reported surface winds, showed that the airspeed during the final portion of the flight was below  $V_x$  but above the listed stall speed from the airplane owner's manual. The owner's manual listed a stall speed with 0° flap setting at maximum gross weight was 64 mph.
