# Aviation Investigation Final Report

<b>Location:</b>	Houston, Texas	<b>Accident Number:</b>	DCA24FA017
<b>Date &amp; Time:</b>	October 24, 2023, 15:20 Local	<b>Registration:</b>	N510HM (A1); N269AA (A2)
<b>Aircraft:</b>	TEXTRON AVIATION INC 510 (A1); Raytheon Hawker (A2)	<b>Aircraft Damage:</b>	Substantial (A1); Minor (A2)
<b>Defining Event:</b>	Runway incursion veh/AC/person	<b>Injuries:</b>	4 None (A1); 3 None (A2)
<b>Flight Conducted Under:</b>	Part 91: General aviation - Personal (A1); Part 135: Air taxi & commuter - Non-scheduled (A2)

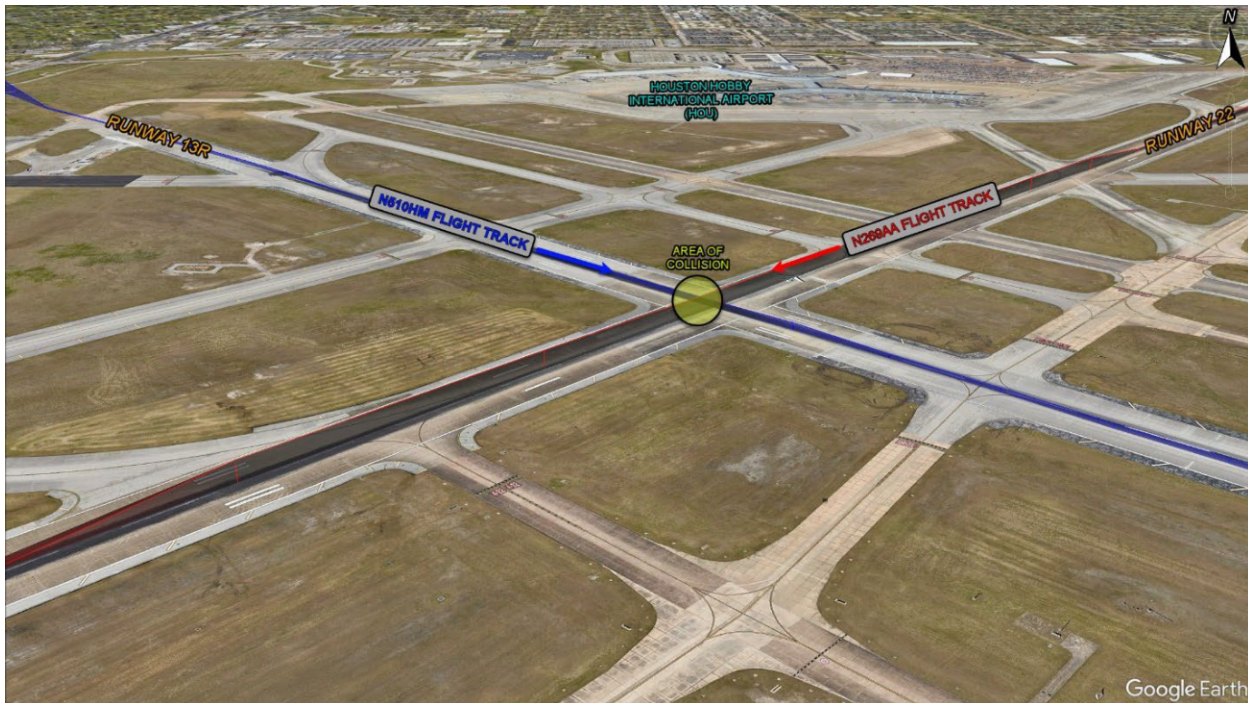
HOU has intersecting runways, and at the time of the accident N510HM was rolling out after landing on runway 13R, while N269AA was on its takeoff roll on runway 22. See figure 1.

**Figure 1.** View of both airplanes’ flight tracks with the area the ground collision occurred highlighted in yellow. The blue line represents the N510HM flight track, and the red line represents the N269AA flight track.

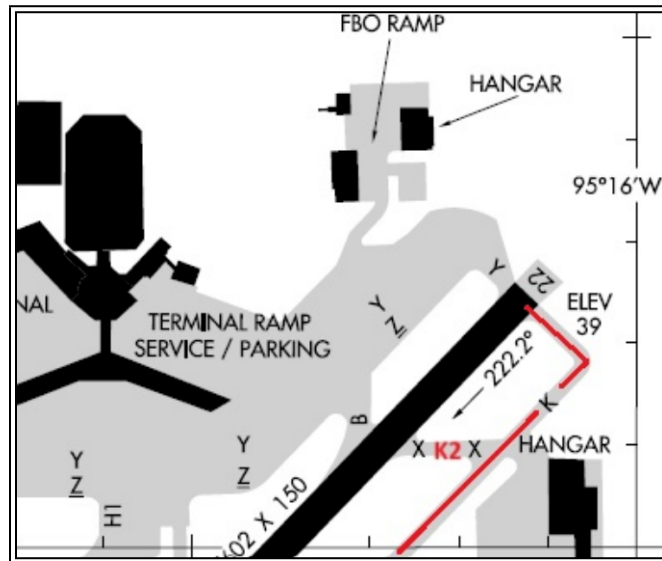
The pilot flying (PF) recalled that he felt “a little bit rushed” due to what he believed was a takeoff clearance and he did not want to delay too long on the runway. He said the crew discussed the speeds and knew what they should be, so they elected to go. The PF recalled hearing only a clearance for takeoff, while the PM recalled hearing the LUAW clearance followed by a clearance for takeoff. Both pilots recalled hearing the clearance for takeoff about the time they began the left turn toward the runway at the end of taxiway Kilo. See figure 2 below.

**Figure 2.** Taxiways K (Kilo) and K2 (Kilo 2) at the departure end of runway 22.

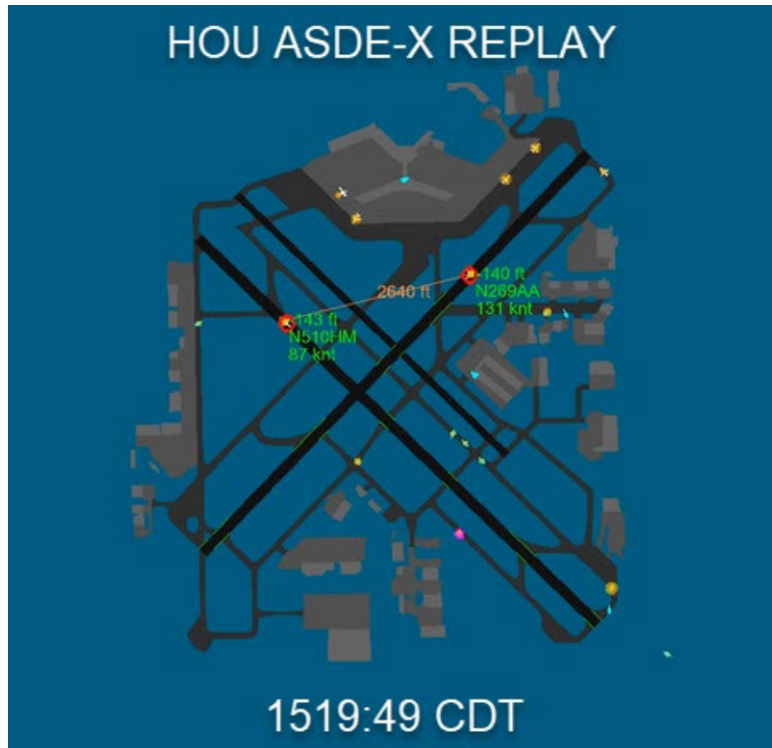
During the event, the ASDE-X system first alerted controllers to a perceived collision between the two airplanes at 15:19:49, about 11 seconds before the collision occurred. Figure 4 shows the ASDE-X replay at this time.

**Figure 4.** ASDE-X display at time of first alert.

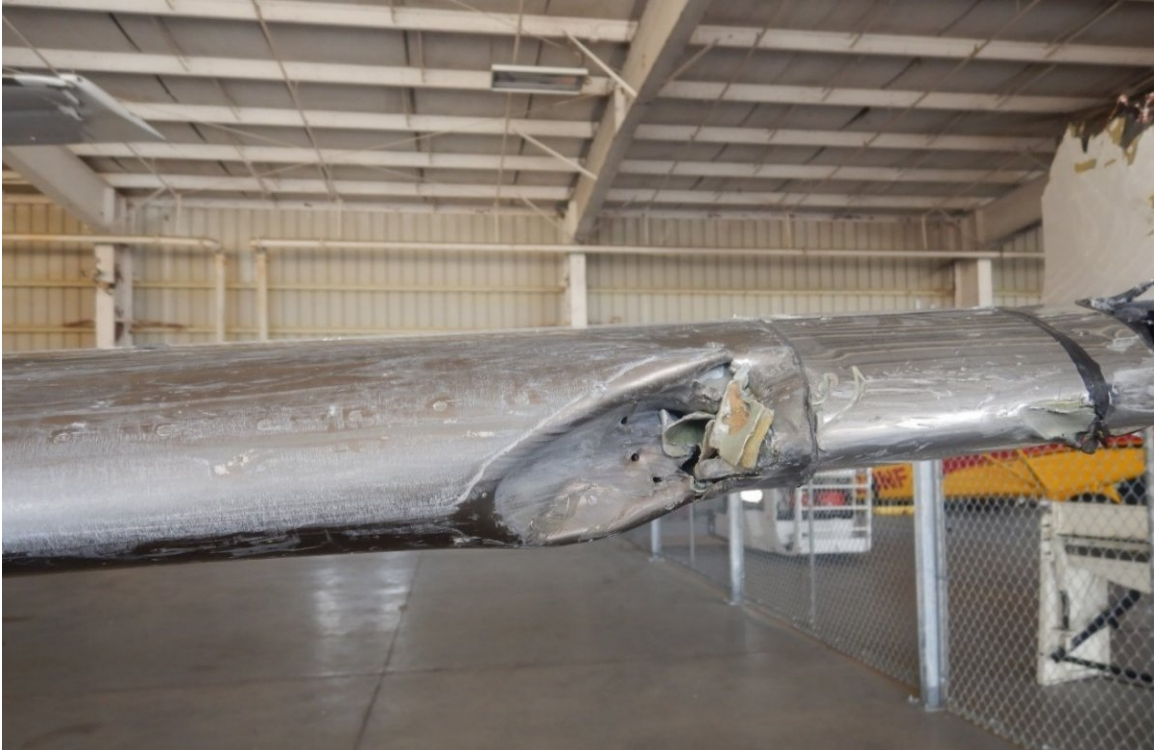
Post-accident examination of N269AA revealed impact damage to the left wing. The titanium leading-edge panel exhibited a “V-shape” aft indentation to the wing front spar with sheet metal remnants of the Cessna Mustang embedded, see figure 5.

**Figure 5.** Close up view of N269AA's left-wing leading-edge damage.

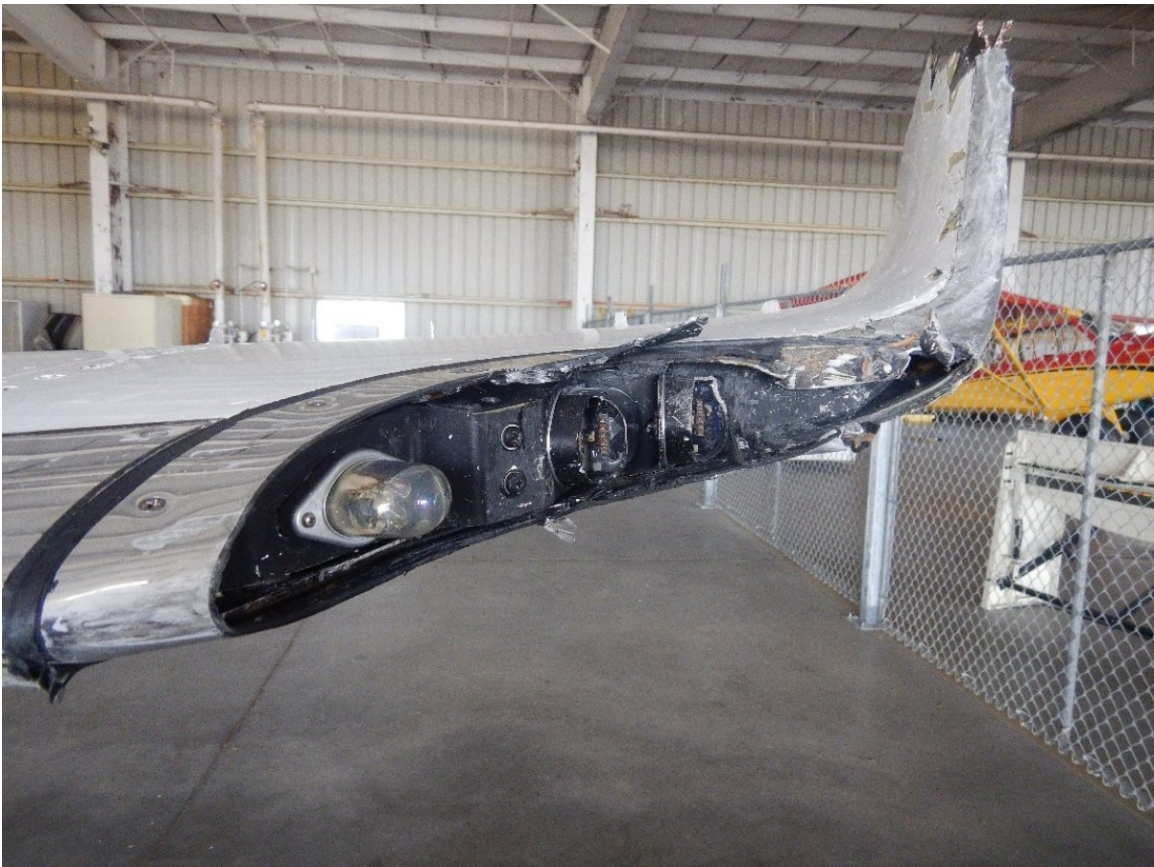
N269AA’s left-wing winglet remained attached to the left wing. The winglet leading edge exhibited white paint transfer marks and the navigation light lens was impact separated and pieces of the glass were found in the Cessna Mustang’s tail cone/stinger. About ten inches of the top section of N269AA’s winglet had separated due to the impact with N510HM, see figure 6.

**Figure 6.** Close up view of N269AA's left winglet/navigation light assembly damage.

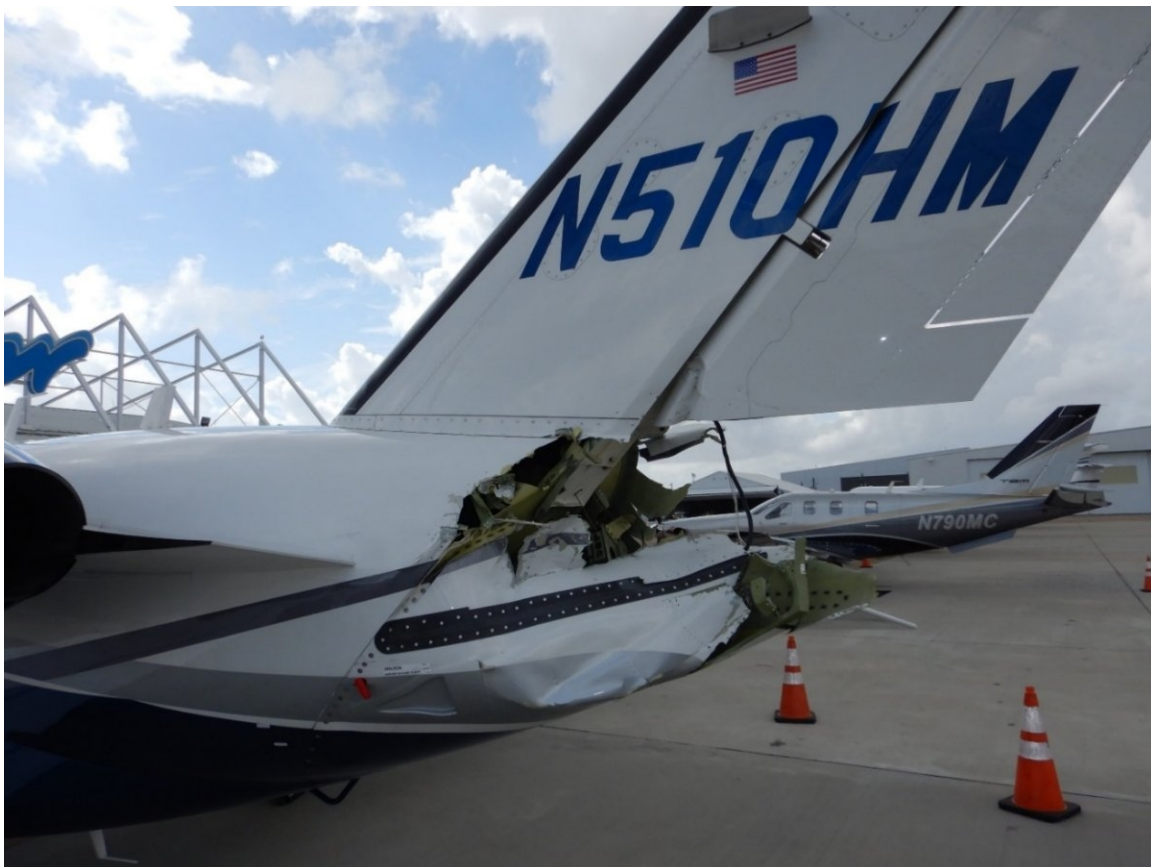
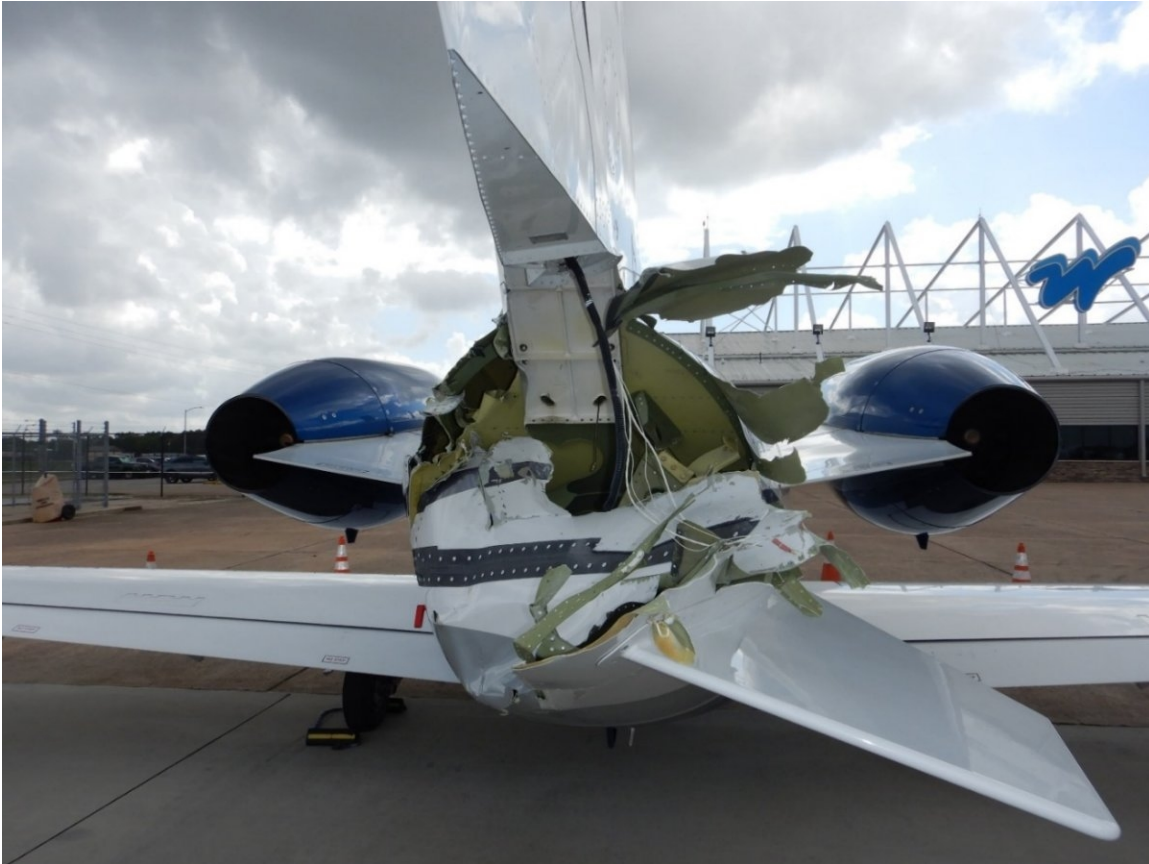
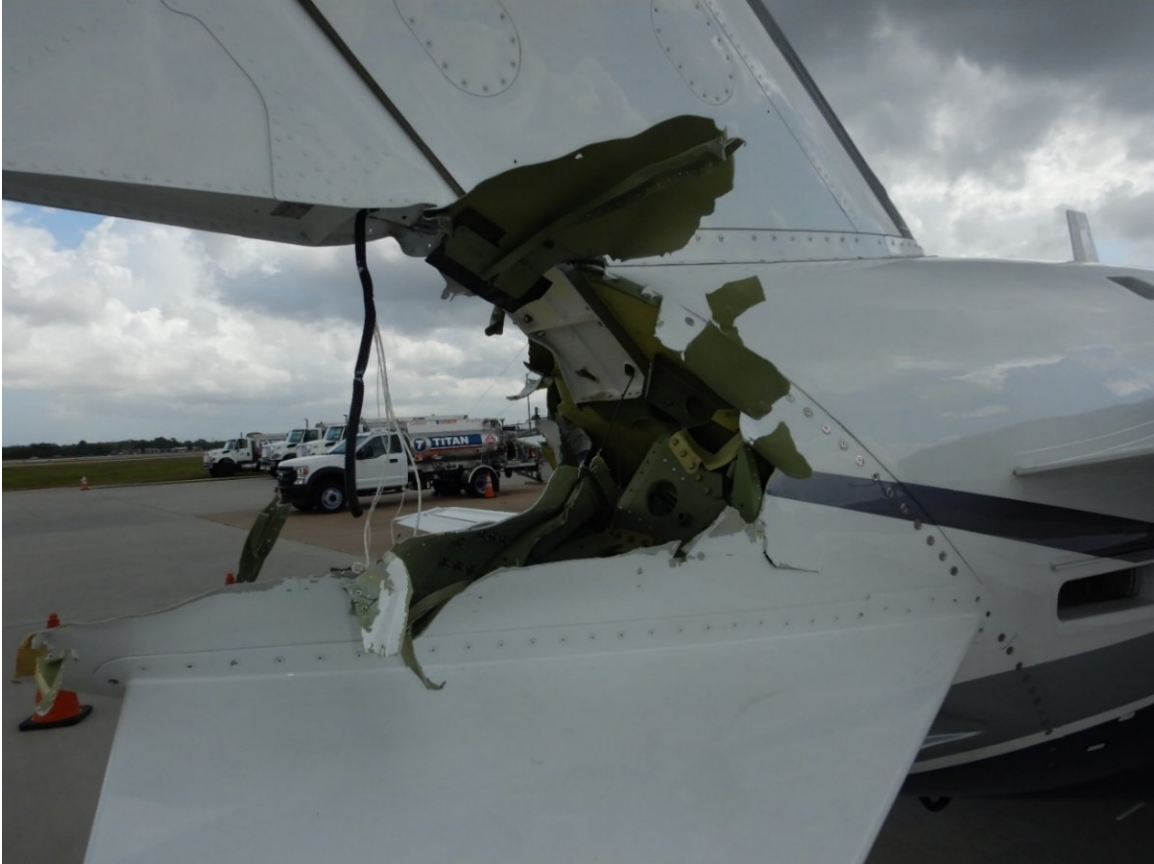
Post-crash examination of N510HM revealed that the left side of its tail section had been impacted by the left wing of N269AA. The torn skin on the tail section was consistent with N269AA's wing penetrating the left side of N510HM's tail stinger and exiting the right side, severing a portion of the stinger. The impact damage was isolated to the area of the empennage, see figures 7, 8 and 9.

The impact fractured and separated a section of the aft canted bulkhead. A section of the aft horizontal stabilizer spar, common to the rudder sector attach point, was torn and bent consistent with the wing impact. The rudder sector mount was torn from the structure at the fastener locations.

The rudder torque tube was fracture separated from the rudder control sector and the rudder. The upper and lower left and lower right rudder control cables were broken in a manner consistent with tensile overload. The upper right rudder control cable remained intact, but the ball end was pulled from the rudder sector. The autopilot rudder servo control cable was fractured in tensile overload. The left autopilot cable pulley bracket, with pulley attached, was separated from the canted bulkhead. The left strake was impact fractured from the tail cone stinger and was recovered from the runway along with various sheet metal fragments from the stinger.

**Figure 7.** Left side view of N510HM's damage to its empennage.

**Figure 8.** Aft view of N510HM's damage to its empennage.

**Figure 9.** Right side view of N510HM's damage to its empennage.

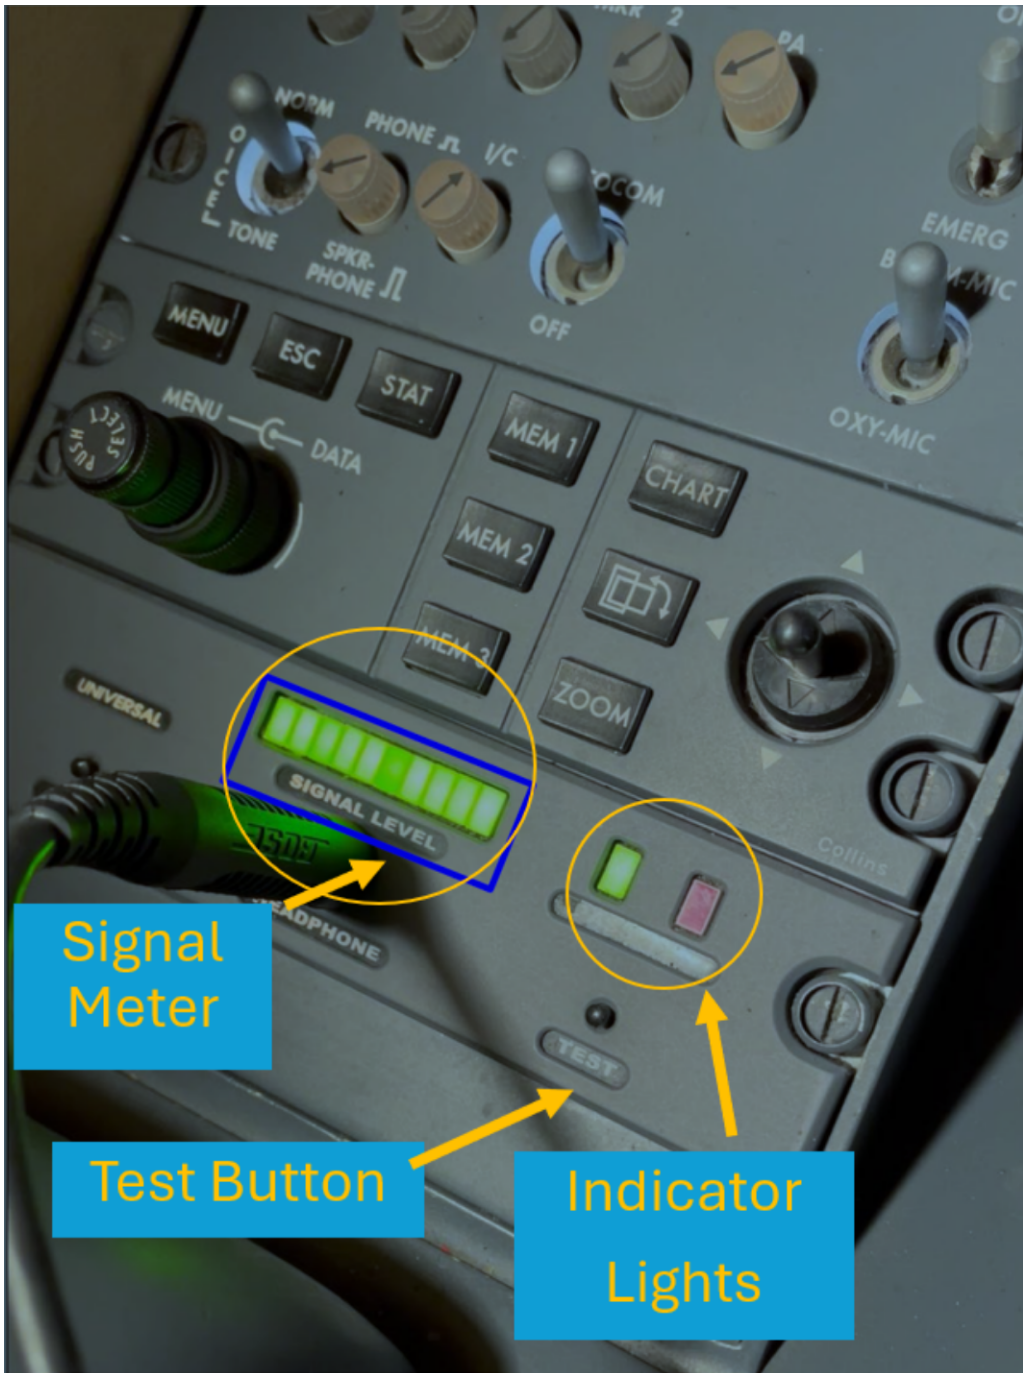
Separately, the chief pilot stated that it was company policy (and an element of the before start checklist) to test the cockpit voice recorder (CVR) prior to every flight. After the accident, the CVR was found to be inoperative due to activation of the impact or G switch, which interrupts electrical power to the CVR and its control unit in the cockpit. This can occur for several reasons, including hard landings or during maintenance operations.

As required by the FAA, the airplane was equipped with a feature to test the CVR, and the operator's procedures required that pilots perform the test prior to every flight. Normally, the test is performed by pressing the "test" button on the CVR control unit, which is in the cockpit on the captain's left side radio panel. The test lasts about 15 seconds, during which the red and green status lights flash alternately, and the green signal meter fully illuminates intermittently. If the test is successful, the green indicator light will illuminate solidly for 10 seconds.

A failed test results in a solid or flashing red indicator light. However, with the inertial switch activated, electrical power is disconnected from the CVR and the CVR control unit, and the self-test cannot be executed. Pressing the test button has no effect, and none of the lights on the CVR control unit will illuminate. When operating normally with no faults (and not in self-test mode), none of the lights on the control unit will be illuminated. The control unit is shown in figure 10.

**Figure 10.** Cockpit voice recorder control unit.

Since the CVR was inoperative, the relevant crew conversations that would have provided additional insight to the investigation were not captured. This demonstrates the importance of properly testing the CVR before each flight.
