Aviation Investigation Preliminary Report

| Location: | Westwater, UT | Accident Number: | WPR24FA083 |
| Date & Time: | February 7, 2024, 10:48 Local | Registration: | N900VA |
| Aircraft: | HAWKER BEECHCRAFT CORP HAWKER 900XP | Injuries: | 2 Fatal |

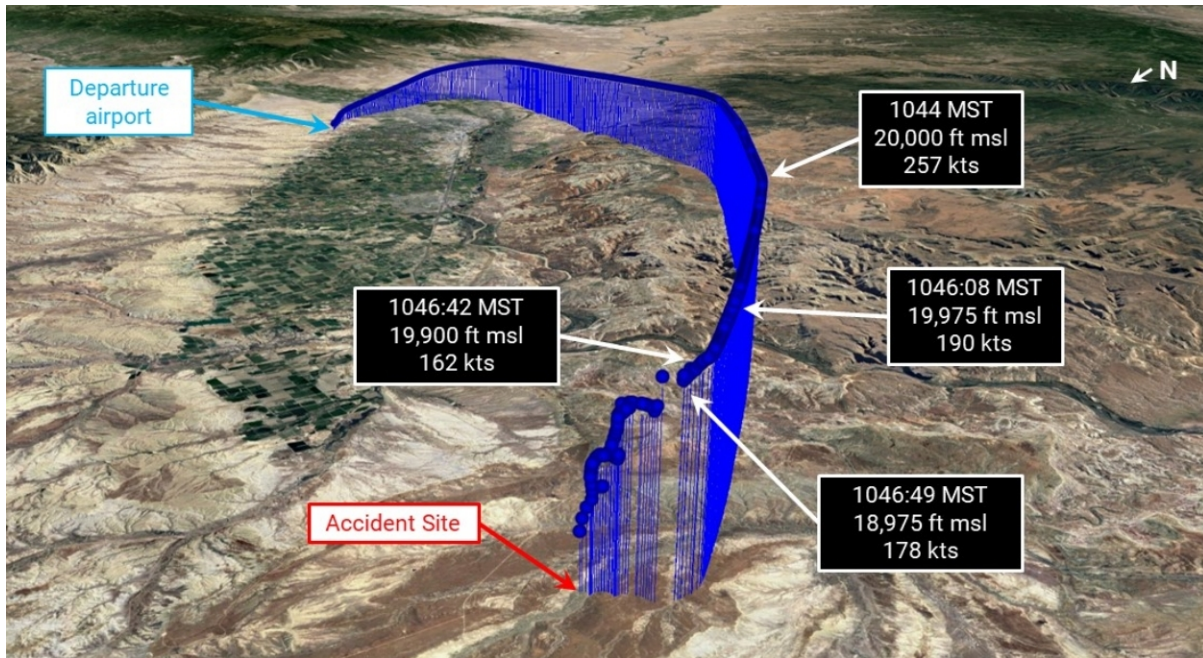
leveled off at 1043:49, near the top of the altitude block. At 1046:47 the flight track data showed the airplane begin a rapid descent in circular pattern that resembled the shape of a corkscrew. The airplane made multiple rotations before the track ceased at 1047:44.

Figure 1: Accident airplane flight track
