# Aviation Investigation Preliminary Report

| <b>Location:</b> | Bath, MI | <b>Accident Number:</b> | ANC26FA002 |
| <b>Aircraft:</b> | Raytheon Hawker 800XP | <b>Injuries:</b> | 3 Fatal |

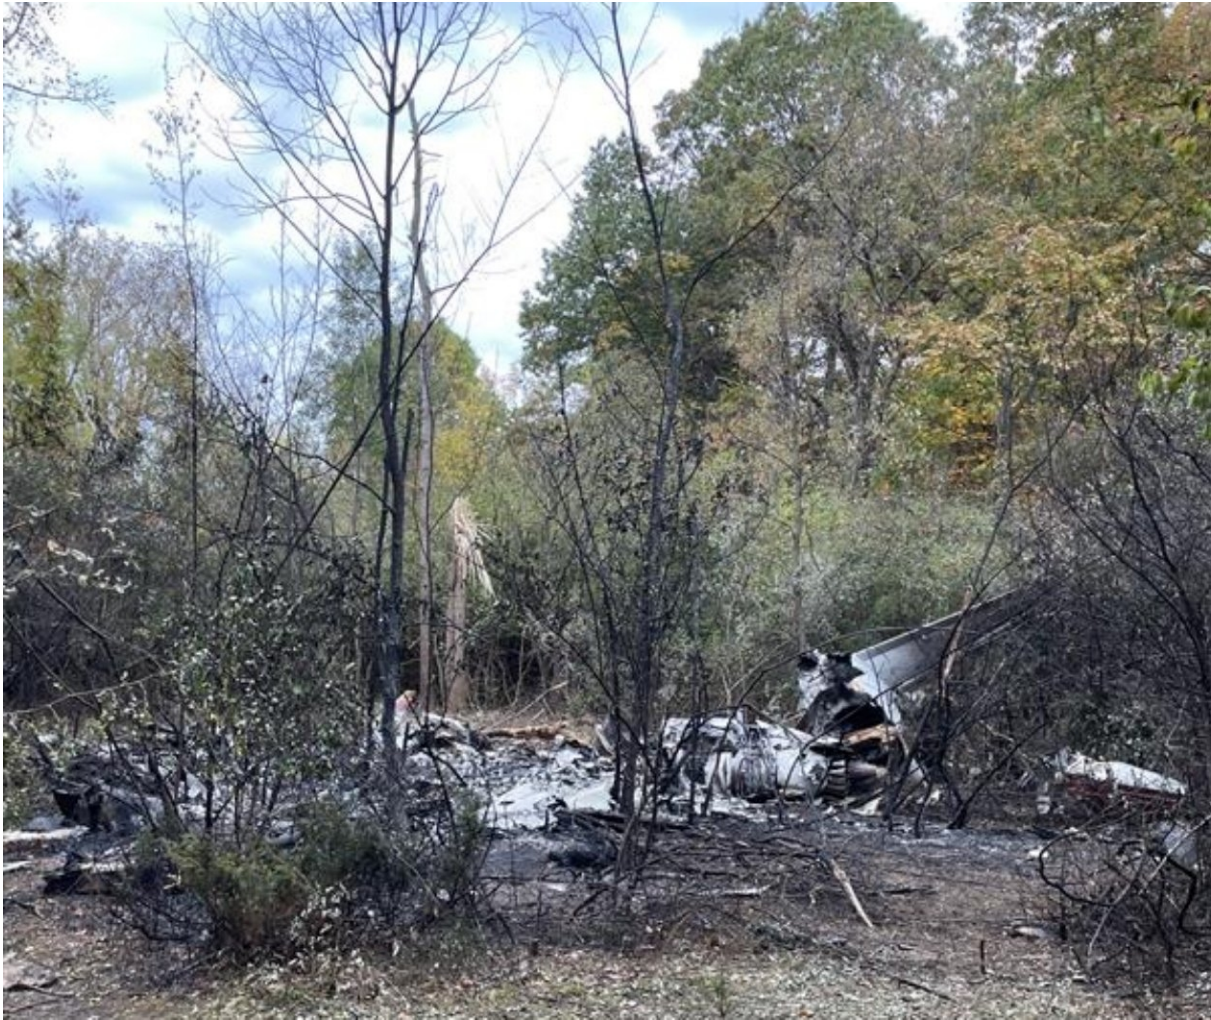
The airplane came to rest in a wooded area about 9 miles northeast of BTL at an elevation of 850 ft mean sea level and oriented on a magnetic heading of 150°. The airplane impacted terrain in a relatively flat attitude. A postimpact fire consumed a large portion of the main wreckage with the exception of a portion of the right wing, both winglets, and the empennage section. All major structures were accounted for at the accident site.

Figure 1 View of accident site main wreckage.
