# Aviation Investigation Final Report

<b>Location:</b>	Westwater, Utah	<b>Accident Number:</b>	WPR24FA083
<b>Date &amp; Time:</b>	February 7, 2024, 10:48 Local	<b>Registration:</b>	N900VA
<b>Aircraft:</b>	HAWKER BEECHCRAFT CORP HAWKER 900XP	<b>Aircraft Damage:</b>	Destroyed
<b>Defining Event:</b>	Loss of control in flight	<b>Injuries:</b>	2 Fatal
<b>Flight Conducted Under:</b>	Part 91: General aviation - Positioning

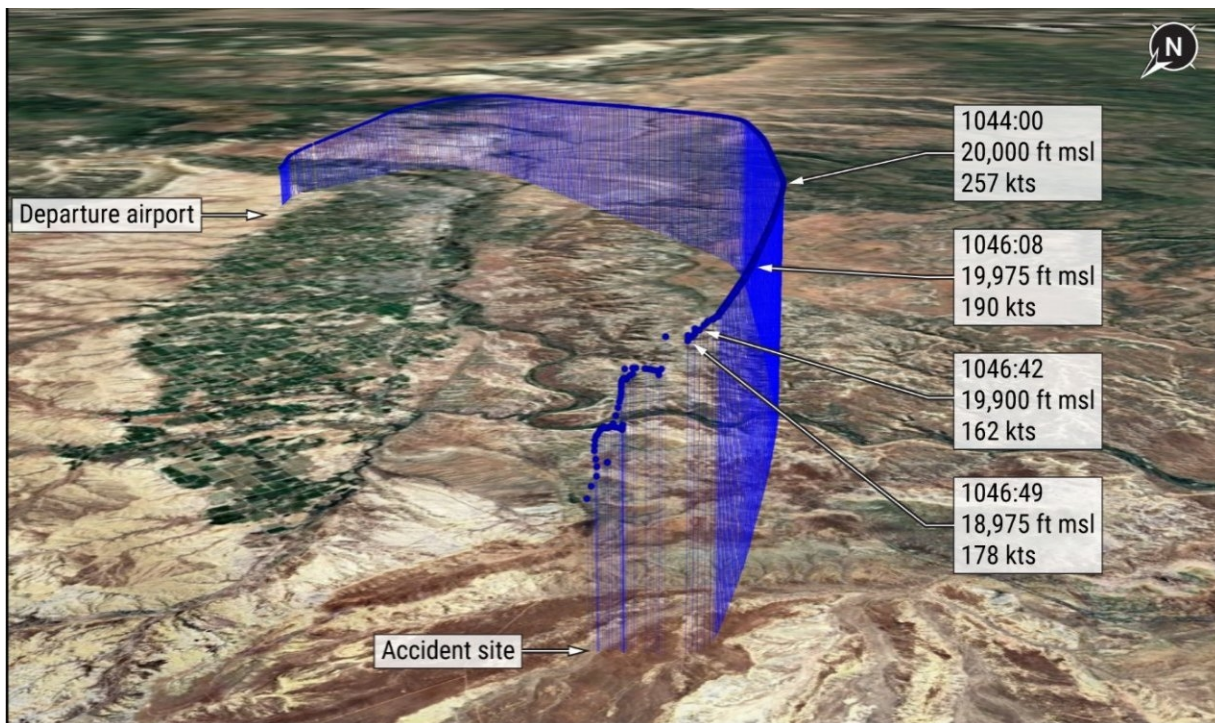
At 1046:47 the flight track data show the airplane began a rapid descent in a pattern resembling the shape of a corkscrew. The airplane’s flight track made multiple circular rotations before ending at 1047:44.

Figure 1: Accident airplane flight track and corkscrew descent

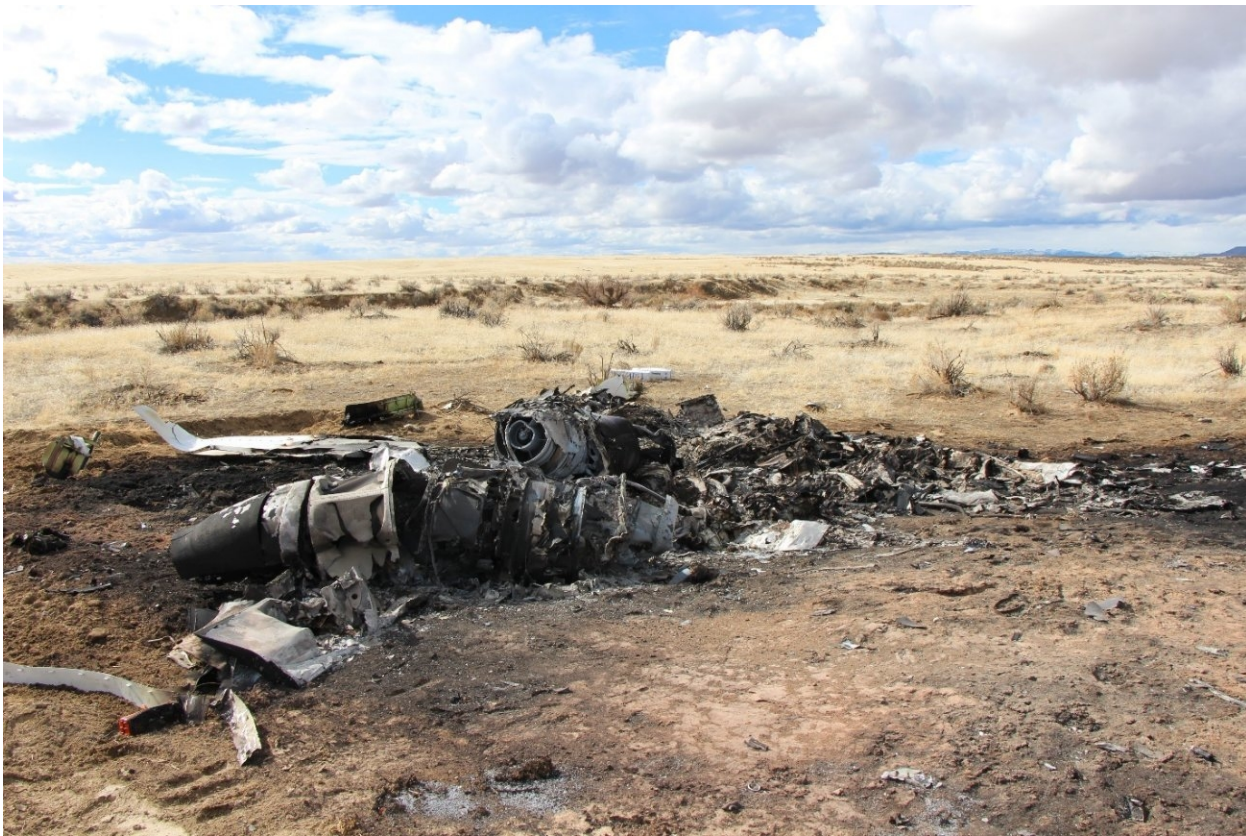
The airplane came to rest in flat open terrain about 25 nm northwest of GJT at an elevation of about 4,800 ft mean sea level and oriented on a west heading. The airplane's major structures were all accounted for at the accident site. A debris path was traced from the main wreckage to the end of a burn area that was about 200 ft long and 175 ft wide at the widest point, oriented on a magnetic heading of 345°. A silhouette of the left wing, fuselage, and both engines was located about 10 ft south of the main wreckage.

Figure 2: Accident site main wreckage

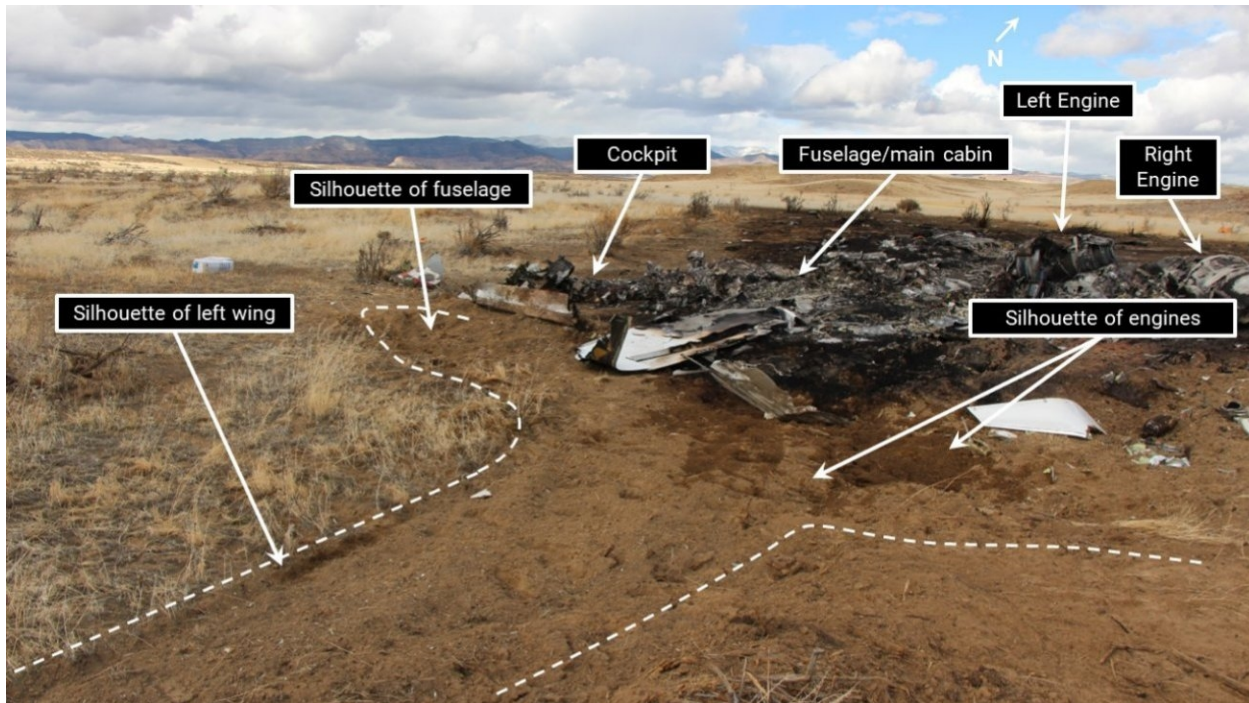
Figure 3: Silhouette of left wing and fuselage with consumed main wreckage in background

The airplane wings and leading edges were mostly destroyed by postcrash fire. Those areas that remained intact were either significantly damaged or covered in soot.
