# Aviation Investigation Preliminary Report

<b>Location:</b>	New York, NY	<b>Accident Number:</b>	DCA26MA161
<b>Date &amp; Time:</b>	March 22, 2026, 23:37 Local	<b>Registration:</b>	C-GNJZ
<b>Aircraft:</b>	Mitsubishi CL-600	<b>Injuries:</b>	2 Fatal, 6 Serious, 33 Minor
<b>Flight Conducted Under:</b>	Part 129: Foreign

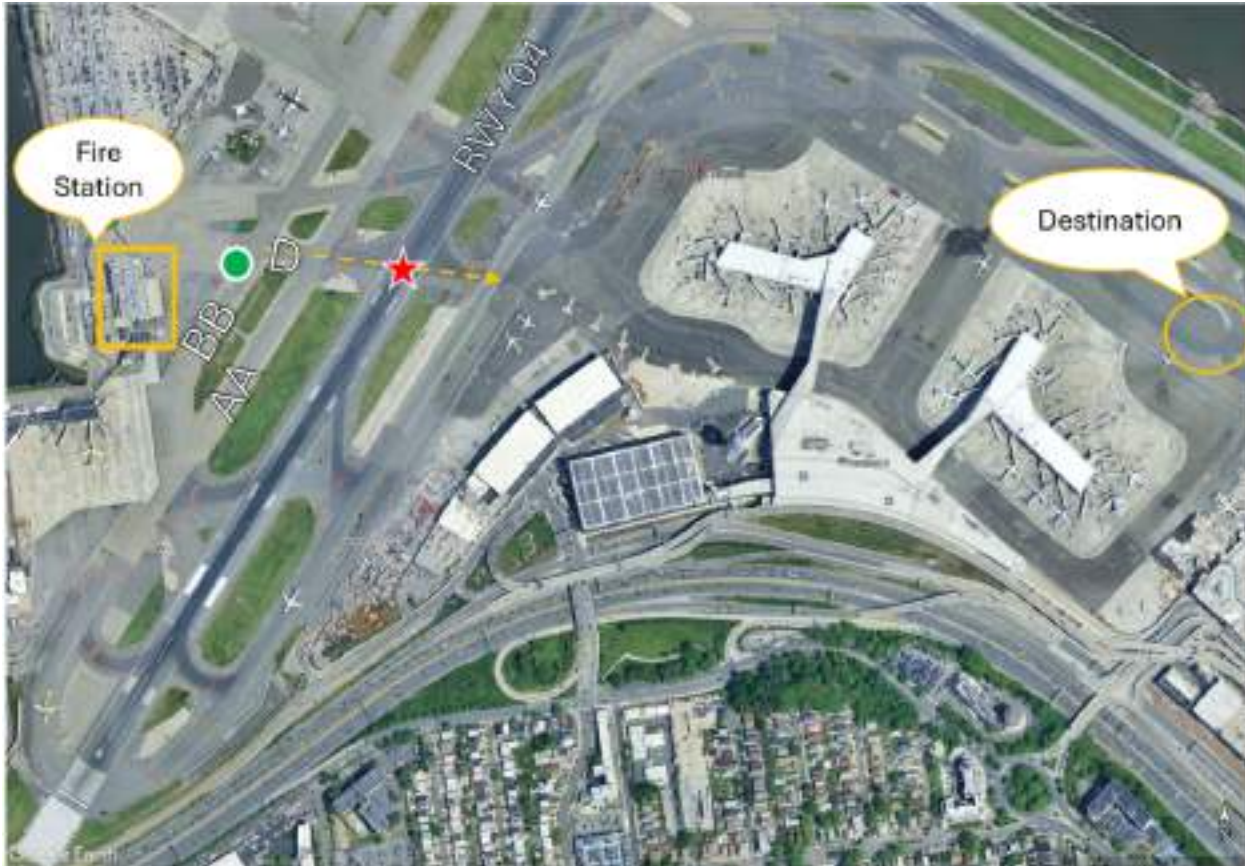
**Figure 1.** Google Earth image of the accident area, with the green circle indicating where the ground vehicles initially gathered, the yellow dash line their intended path on taxiway D, and the red star indicates where the collision occurred.

Truck 1 turned toward the left just prior to the collision. The airplane's rudder deflected about 6° to the left just prior to the end of the flight recorder data. The collision occurred at the intersection of taxiway D and runway 4 denoted by the red star in figure 1. The airplane's last recorded ground speed before the collision was 90 knots (104 mph).

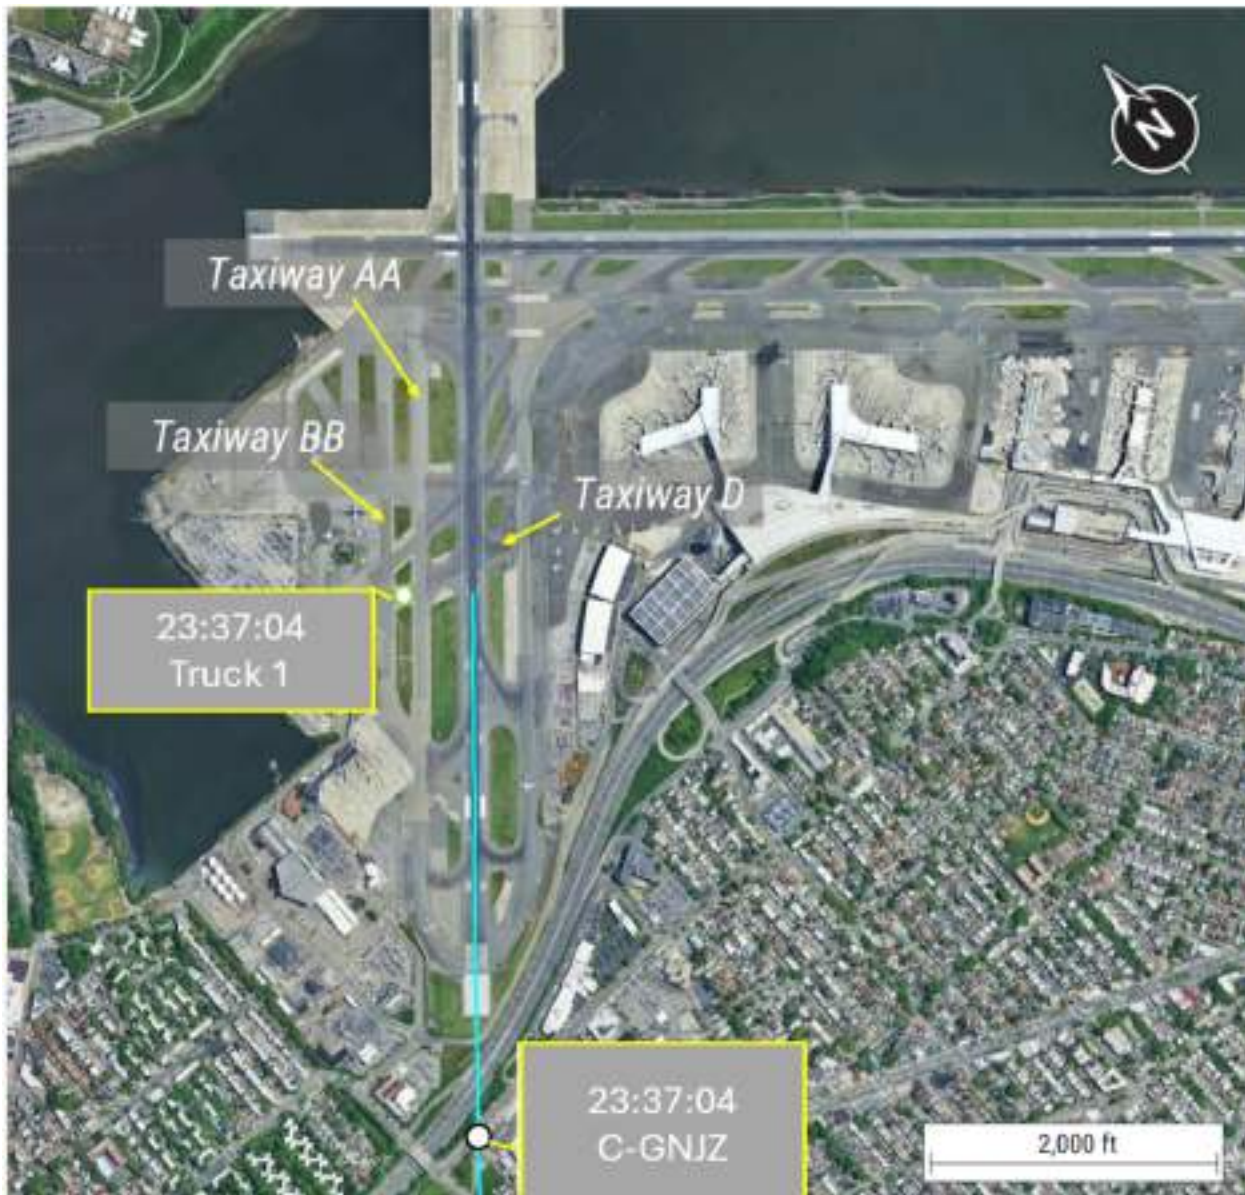
At 2336:56, Truck 1's crew replied to ATC with "Truck 1 and company", and the LC acknowledged. Truck 1 then requested "Truck 1 and company" to cross runway 4 at taxiway D, and the LC instructed them to cross. At that time, 2337:04, the airplane was at an altitude of about 130 ft above ground and about ¼ mile on final approach, which was about 4,400 ft away from taxiway D (see figure 2).

**Figure 2.** R35 (Truck 1) and Jazz flight 646 (C-GNJZ) positions at 23:37:04.

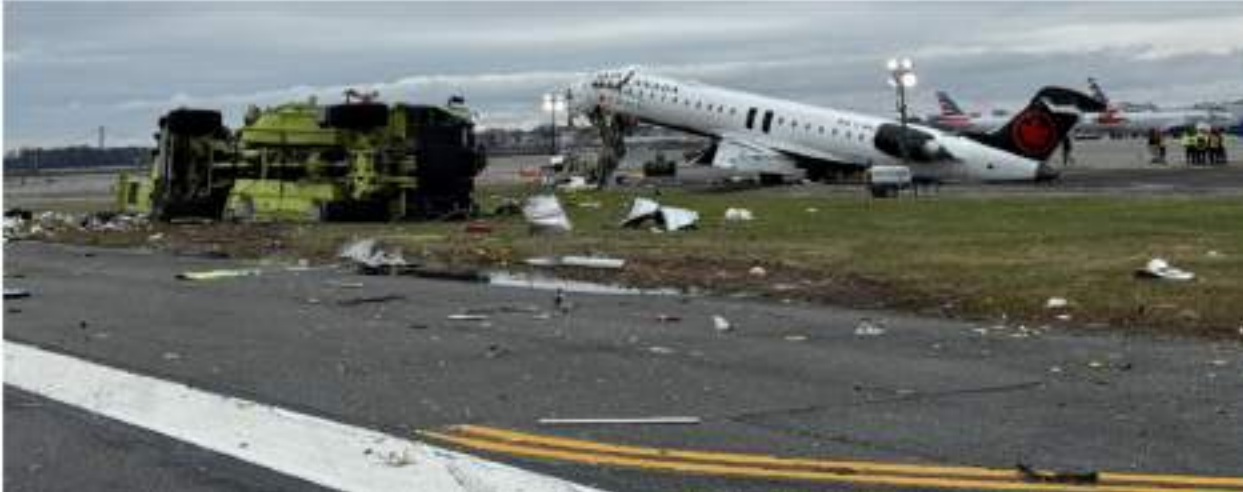
The airplane came to rest adjacent to taxiway B between taxiways D and E, upright on a heading of about 28° magnetic. Initially it was in a nose down attitude, due to the crush damage and partial separation of the forward fuselage and nose landing gear. Truck 1 came to rest just northwest of the airplane, on its left side, on a heading of about 206° magnetic.

**Figure 3.** View of both vehicles after collision.

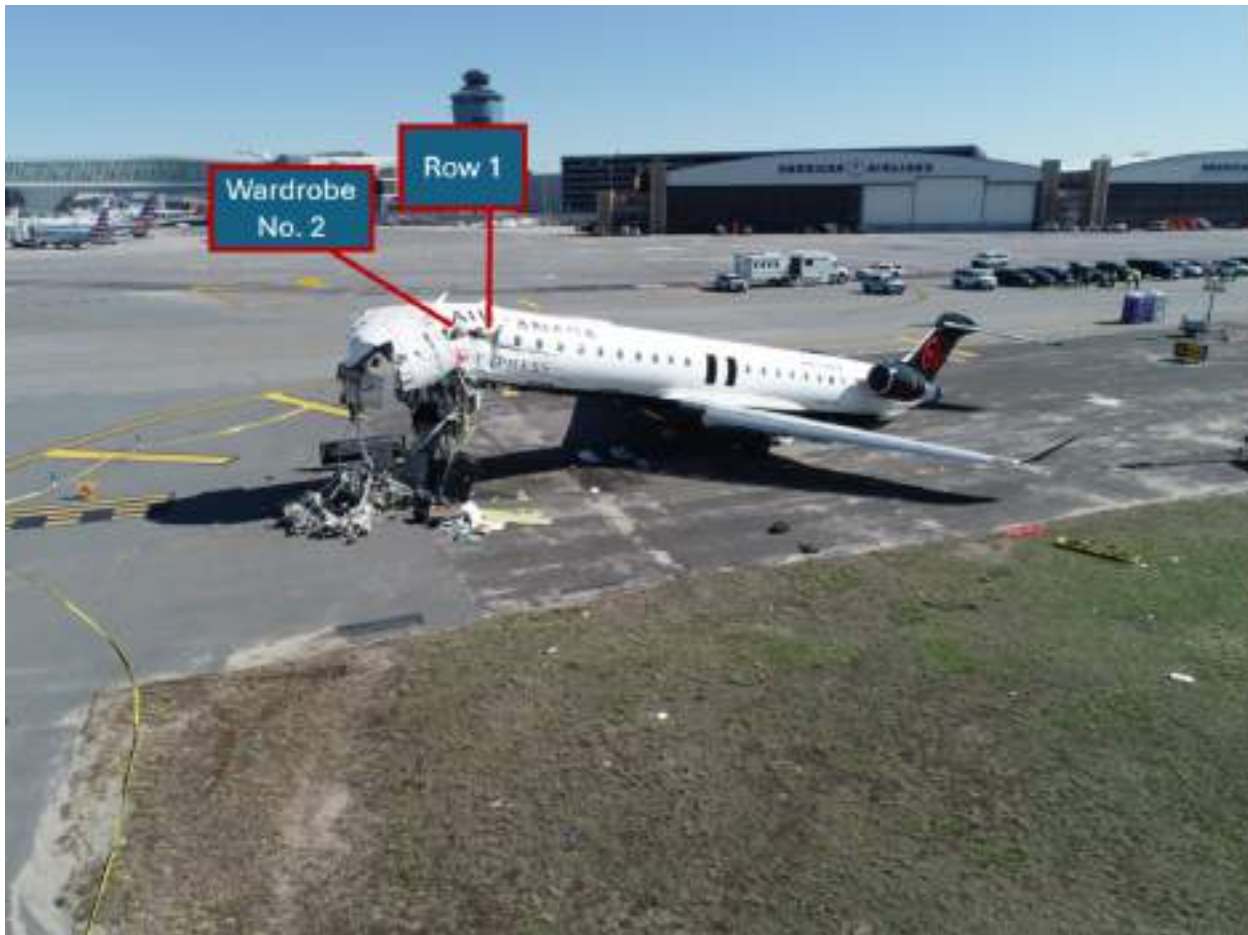
An examination of the airplane revealed that the most severe damage was forward of passenger seat row No. 1. Crush damage extended from the nose, to about the wardrobe No. 2 (coat closet) on the left side of the cabin and to about the forward lavatory on the right side. The two pilot seats, an unoccupied flight deck observer seat, and the forward flight attendant seat were separated from the airplane and found in the debris to the northeast (near the aft end) of Truck 1. All passenger seats were intact and remained secured to their attachment points. Seats 1A and 2A had inboard sidewall and seat leg deformation. The remainder of the passenger seats sustained minor or no damage.

There were no anomalies found with the pitch, roll, or yaw flight control surfaces. The leading edge slats and trailing edge flaps were found in their fully extended positions. All eight spoilers were found in the retracted position, however a review of the flight recorder data indicated that the ground spoilers activated about six seconds before the end of recorded data. Both thrust reversers were found in their fully deployed positions.

**Figure 4.** A view of the accident airplane from the left side.

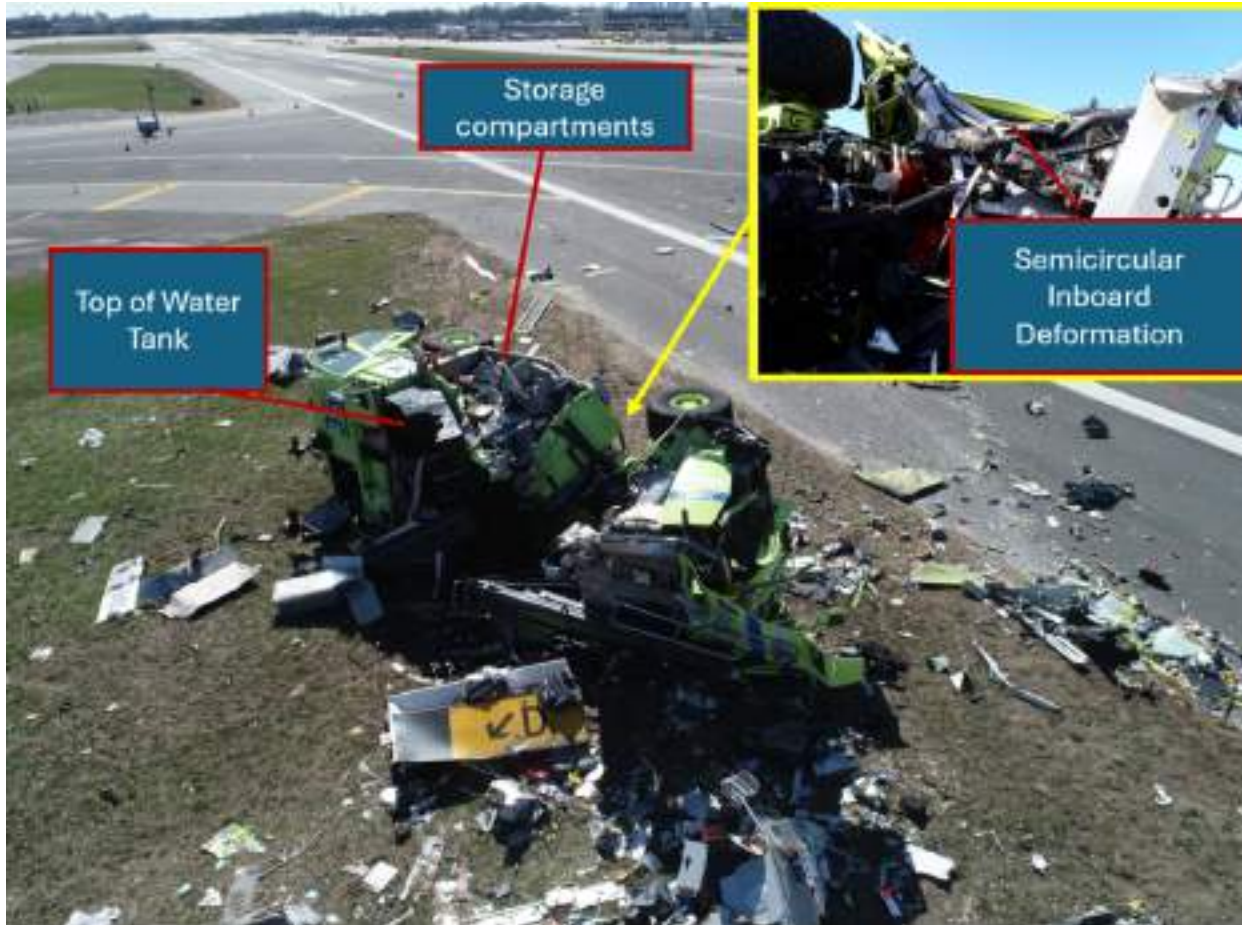
Examination of the R35 ARFF truck revealed it sustained substantial damage to its right-side body structure and equipment storage compartments. The 1,500-gallon water tank was fragmented, and all of the water was released. The 210-gallon foam tank was largely intact, though breached, and all of the foam was released. The right-side body structure had a semicircular indentation in the inboard direction, just forward of the right rear wheel. The operator cab was largely undamaged.

**Figure 5.** Truck 1 with a view of the right and top side of the truck.

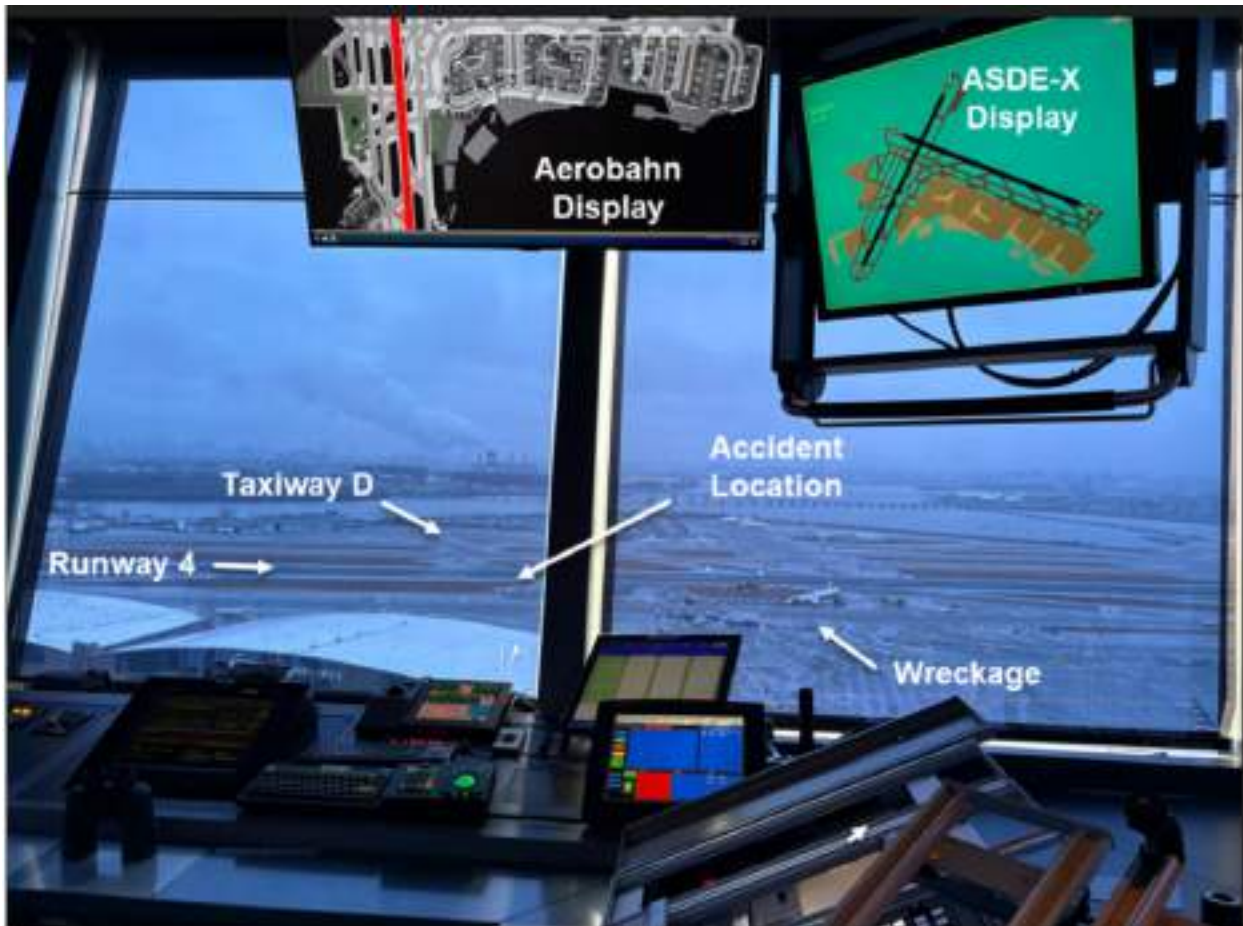
**Figure 6.** Photo taken from the ground control position looking toward runway 4 at taxiway D.

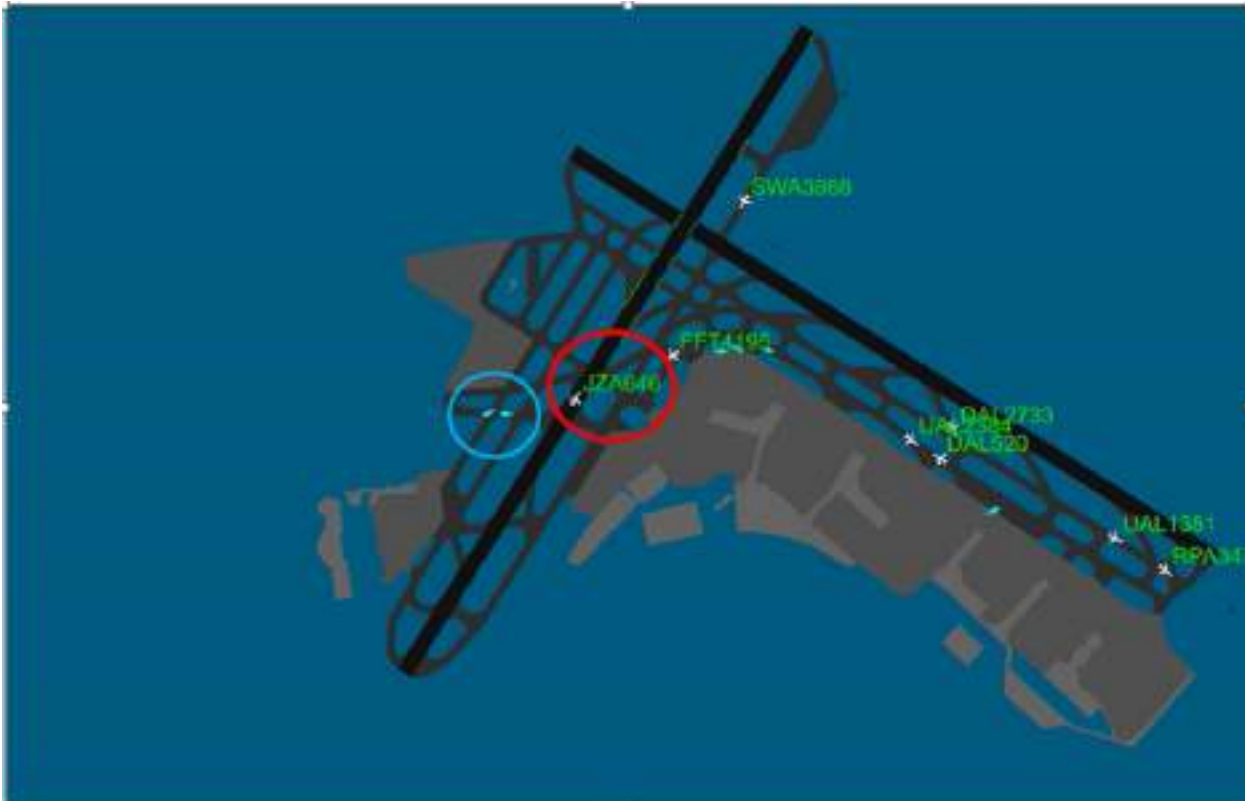
Multiple ground vehicles, none of which were equipped with transponders, were intermittently detected as radar targets, while holding on taxiway D at taxiway BB. However, due to their close (and varying) proximity to each other, and the intermittent merging and unmerging of radar targets, the ASDE-X system was unable to establish high-confidence tracks. At the time of the accident, ASDE-X displayed only two radar targets on taxiway D (near taxiway BB), rather than all seven of the response vehicles as distinct targets at their respective locations, see figure 7.

Without transponder-equipped vehicles, the ASDE-X system could not uniquely identify each of the seven responding vehicles or reliably determine their positions, or tracks. As a result, the system was unable to correlate the track of the airplane with the track of Truck 1 (or any of the other vehicles in the group) and did not predict a potential conflict with the landing airplane.

**Figure 7.** ADSE-X display just after the accident airplane passed taxiway D. JZA646 is the accident airplane and is shown within the red circle. The ground vehicles targets are shown in the cyan circle. (Source: FAA)

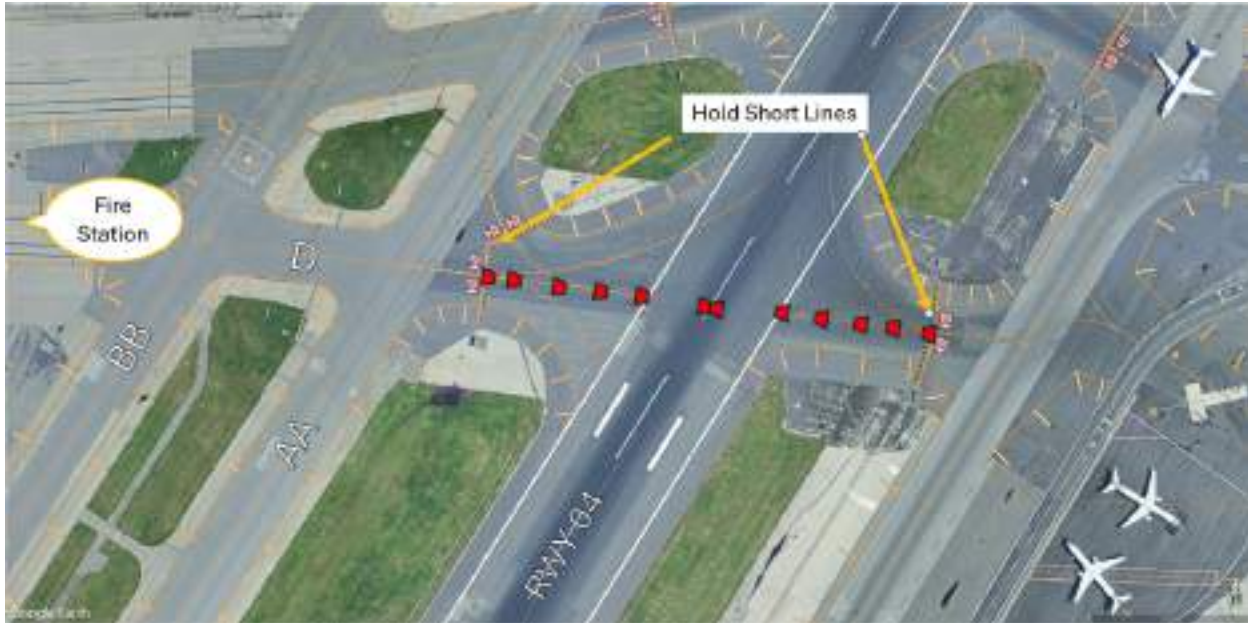
**Figure 8.** Depiction of runway entrance lights (RELs) for the intersection of taxiway D and runway 4.

These red lights are off when no runway traffic is approaching an intersection. They are automatically activated by the ASDE-X system when an airplane is approaching a runway for landing, or on a runway preparing to take off. As a landing airplane approaches the runway, the RELs at each of the equipped intersecting taxiways along the runway are simultaneously illuminated, to warn potential crossing traffic about the landing airplane. After an airplane touches down, the RELs turn off at each taxiway sequentially, as the airplane progresses down the runway. The system is designed to turn the lights off about 2 to 3 seconds before the airplane reaches each intersection.

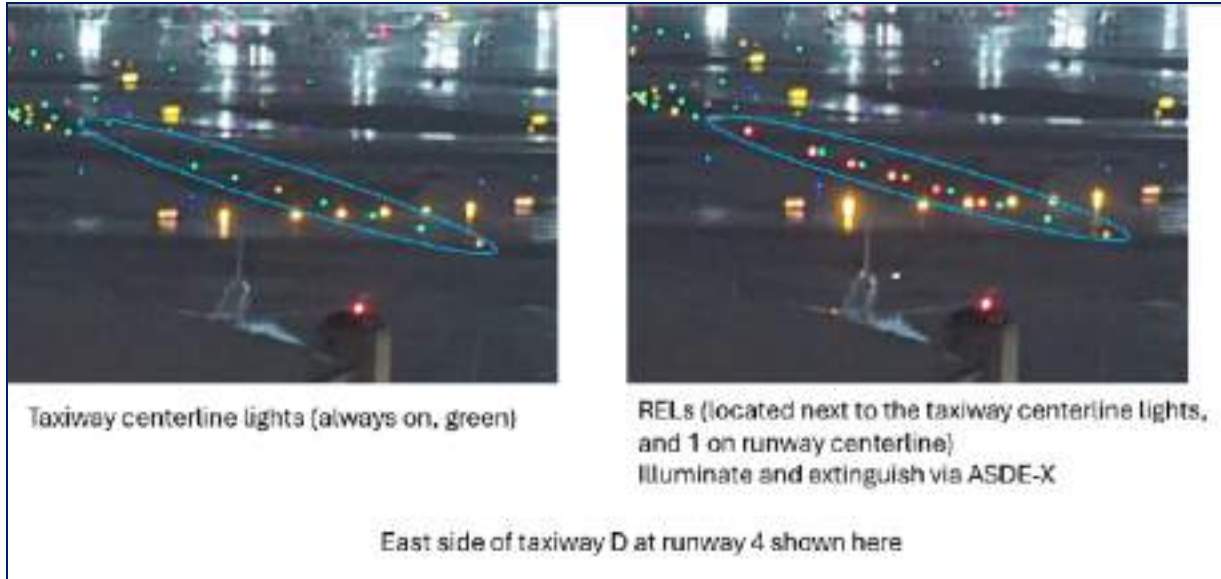
A review of airport surveillance video recordings revealed that the RELs illuminated for the arrival of the accident airplane, as Truck 1 and company were stationary in the vicinity of the taxiway AA and taxiway D intersection, about 300 ft away from the runway 4 hold short line on taxiway D. The RELs on taxiway D remained illuminated until about the time Truck 1 reached the (near) edge of runway, when they extinguished, about 3 seconds prior to the collision. Figure 9 shows surveillance video of the RELs both when off and when activated, on taxiway D east of runway 4.

**Figure 9.** Left image RELs OFF - Right image RELs ON. (Source: Port Authority of New York and New Jersey)
