# Aviation Investigation Preliminary Report

| <b>Location:</b> | Laredo, TX | <b>Accident Number:</b> | CEN26FA228 |
| <b>Date &amp; Time:</b> | June 16, 2026, 22:00 Local | <b>Registration:</b> | N523QS |
| <b>Aircraft:</b> | TEXTRON AVIATION INC 680A | <b>Injuries:</b> | 1 Fatal, 1 Serious, 5 Minor |

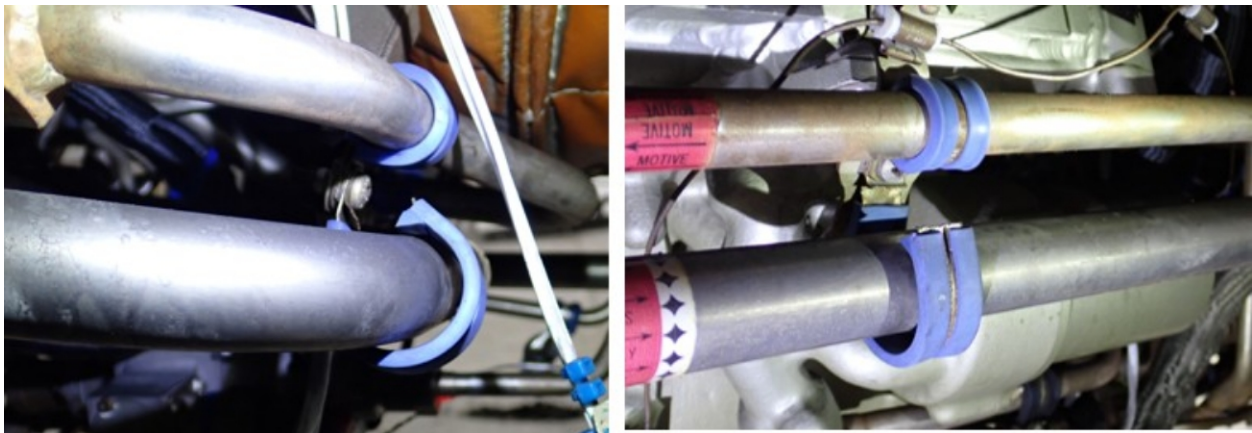
Figure 2. Fractured fuel tube assembly P-clamps

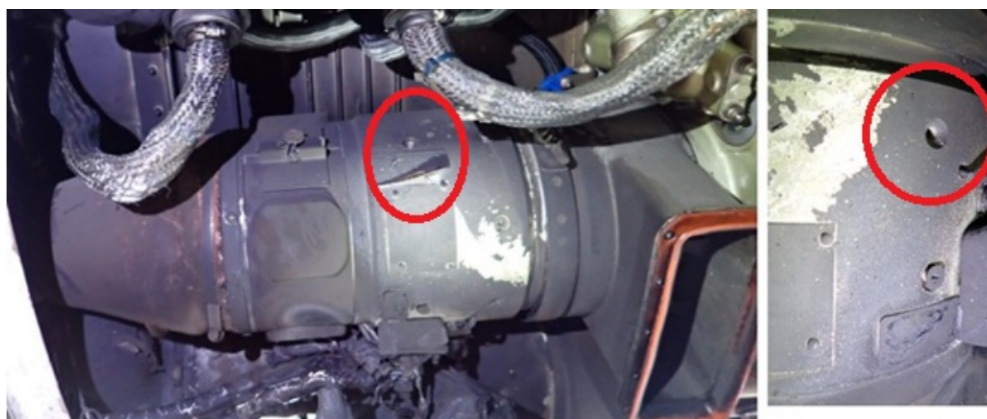
The right engine starter generator (part number 9914685-1; model number 23291-005; serial number P3825) was manufactured by Safran in October 2023. The starter generator was missing multiple screws from the outer housing as shown in Figure 3. The starter generator had 57.2 hours of time remaining since its last overhaul that was performed on April 25, 2025; the overhaul interval was 1,200 hours.

Figure 3. Right engine starter generator and missing screws (red circles)

Upon removal of the starter generator, the starter generator shaft was found bent, the cooling fan was fractured, and multiple cooling fan blades and ball bearings were found when the generator was removed. The cooling fan shroud also contained circumferential scoring marks.
